**Conditions Study for
Southwest Downtown Study Area
Colorado Springs, Colorado**

FINAL

June 2018

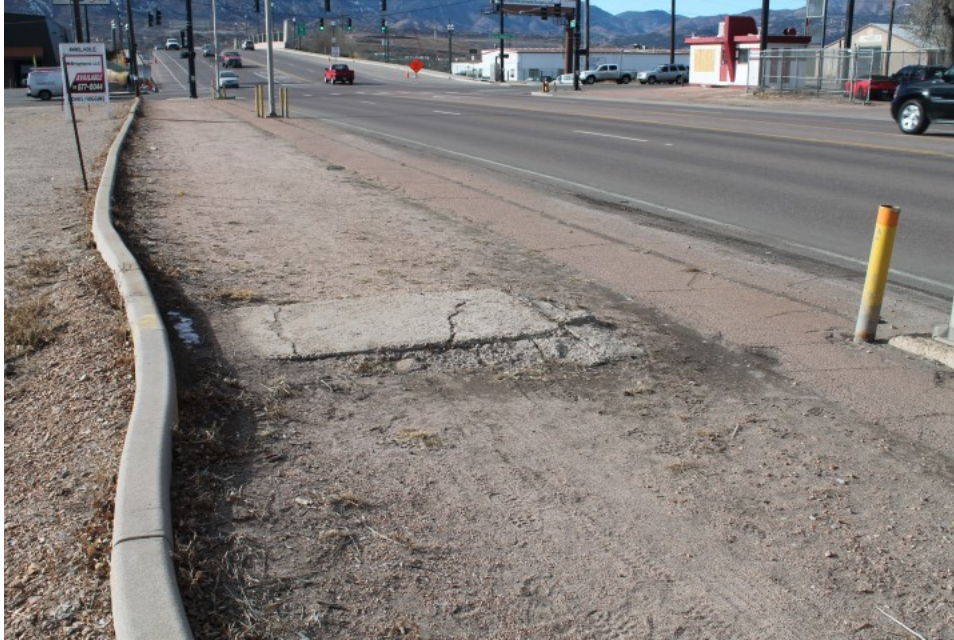
Figure 2-2 Substandard driveway/curb cuts, cracked or uneven pedestrian surfaces, unsafe level changes, deteriorated curb and gutter, inadequate and deteriorated sidewalk, non-conformance to development regulations (Photo A-3)

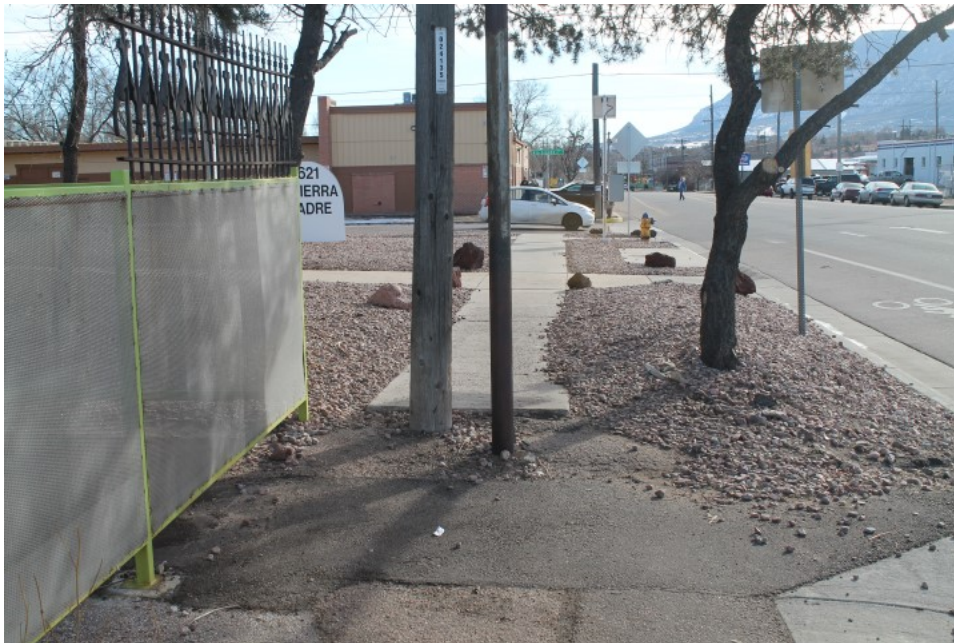
Figure 2-3 Substandard driveway/curb cuts, cracked or uneven pedestrian surfaces, unsafe level changes, deteriorated curb and gutter, inadequate and deteriorated sidewalk, non-conformance to development regulations (Photo A-9)

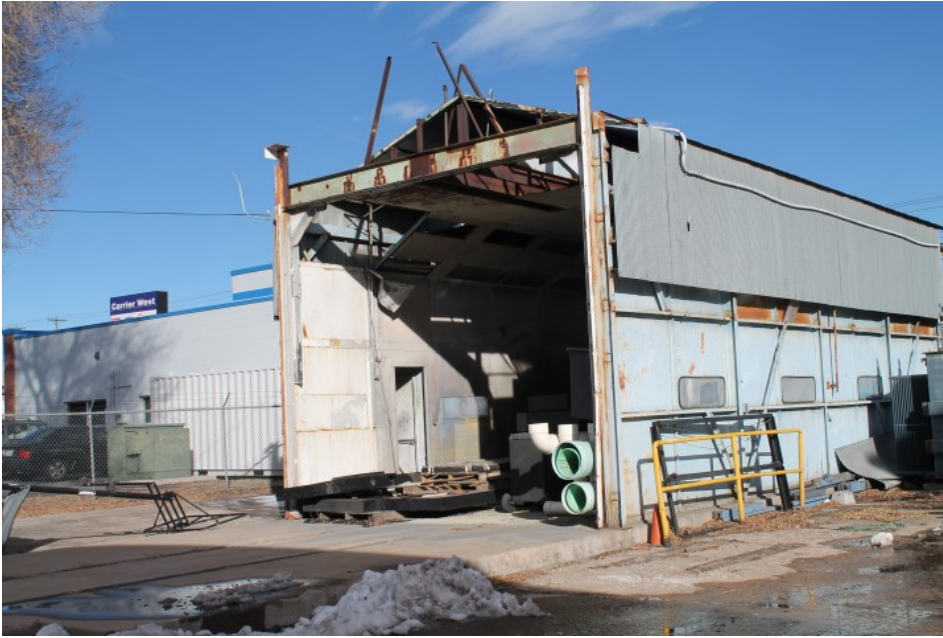
Figure 2-4 Multiple examples of deteriorated building exterior and structure, potentially hazardous conditions, unsafe level changes, building code violations, dilapidated building interior, unprotected electrical systems, inadequate fire suppression systems (Photo A-17)

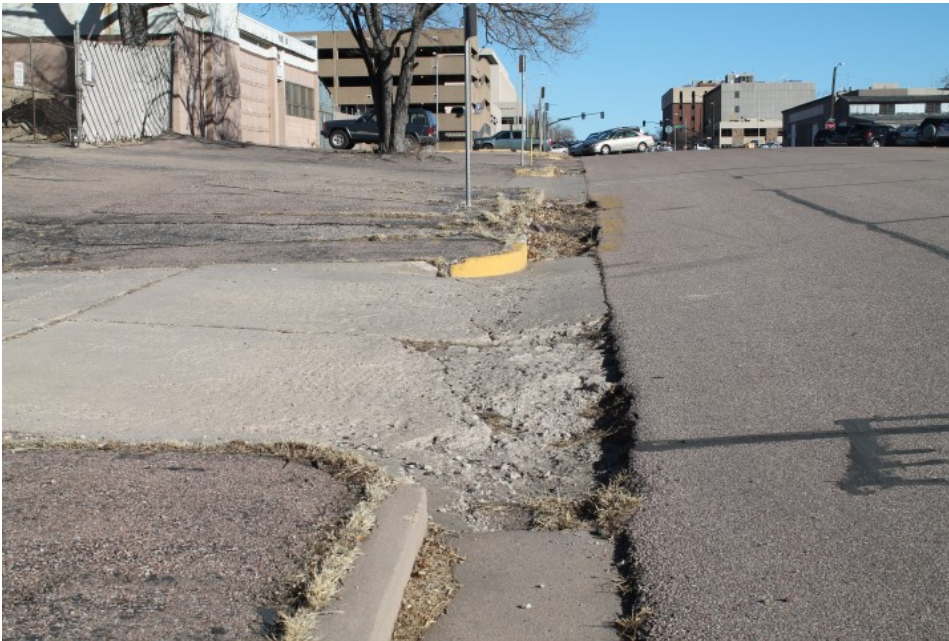
Figure 2-5 Presence of trash and debris, substandard driveway/curb cuts, cracked and uneven surfaces, unsafe level changes, deteriorated curb and gutter, inadequate and deteriorated sidewalk, inadequate site maintenance, non-conformance to development regulations (Photo B-11)

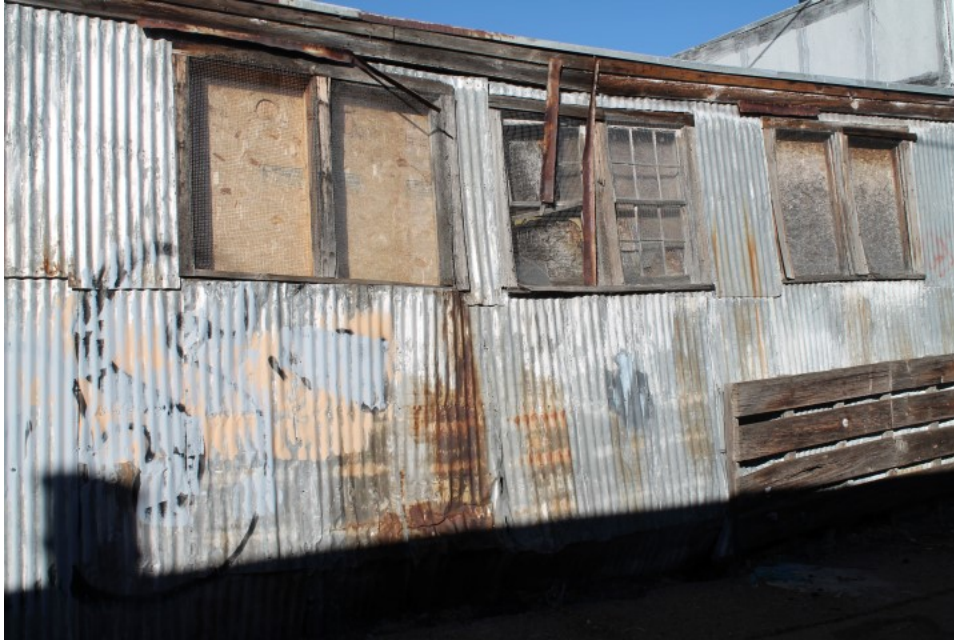
Figure 2-6 Multiple examples of deteriorated building exterior and structure, vagrants/vandalism/graffiti, building code violations (Photo B-16)

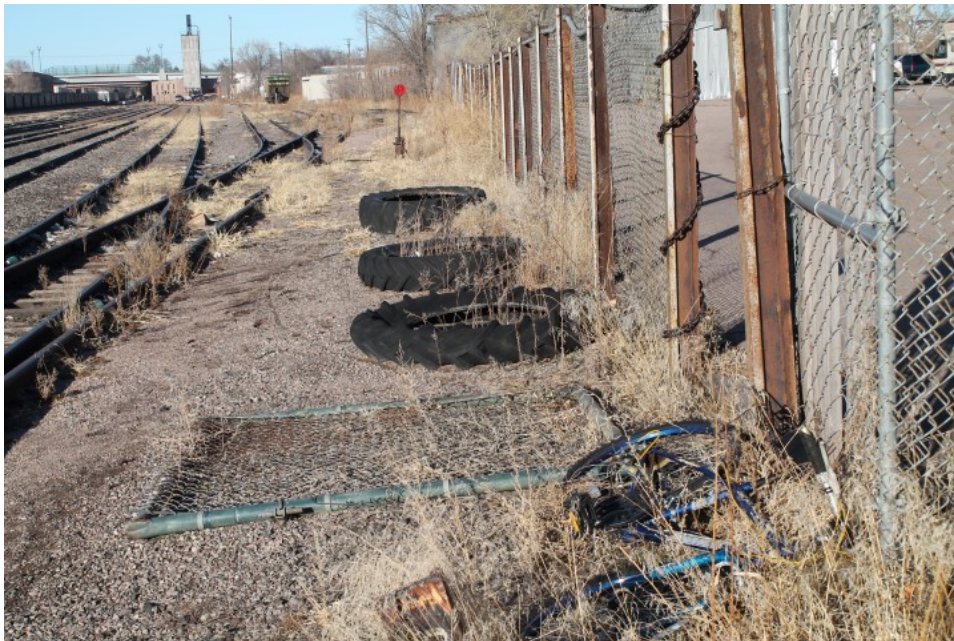
Figure 2-7 Presence of trash and debris, abandoned/inoperable equipment, potentially hazardous conditions, vagrants/vandalism/graffiti, inadequate site maintenance, non-conformance to development regulations (Photo B-29)

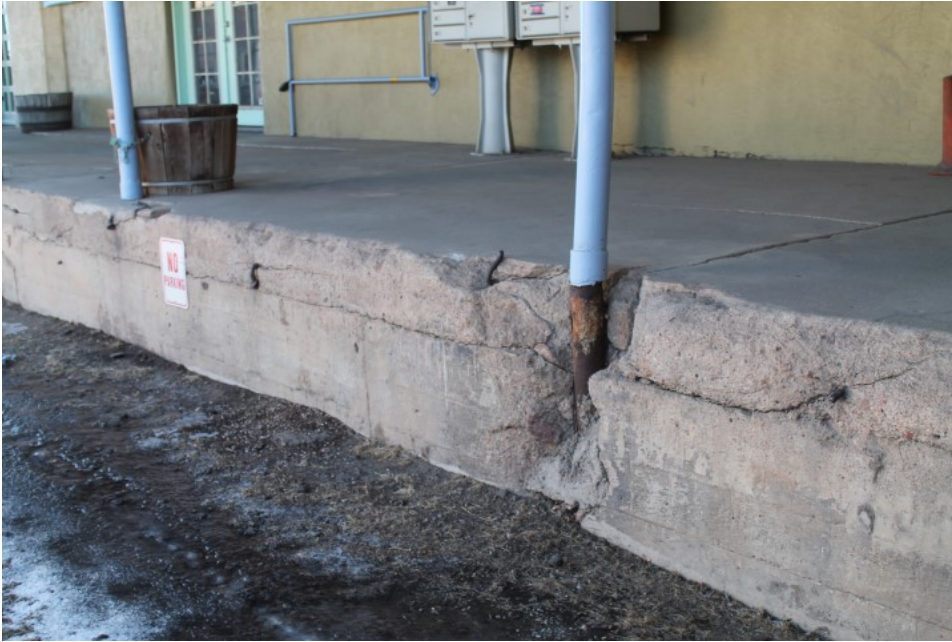
Figure 2-8 Deteriorated visible foundation, deteriorated gutter/downspouts, potentially hazardous conditions, unsafe level changes (Photo C-2)

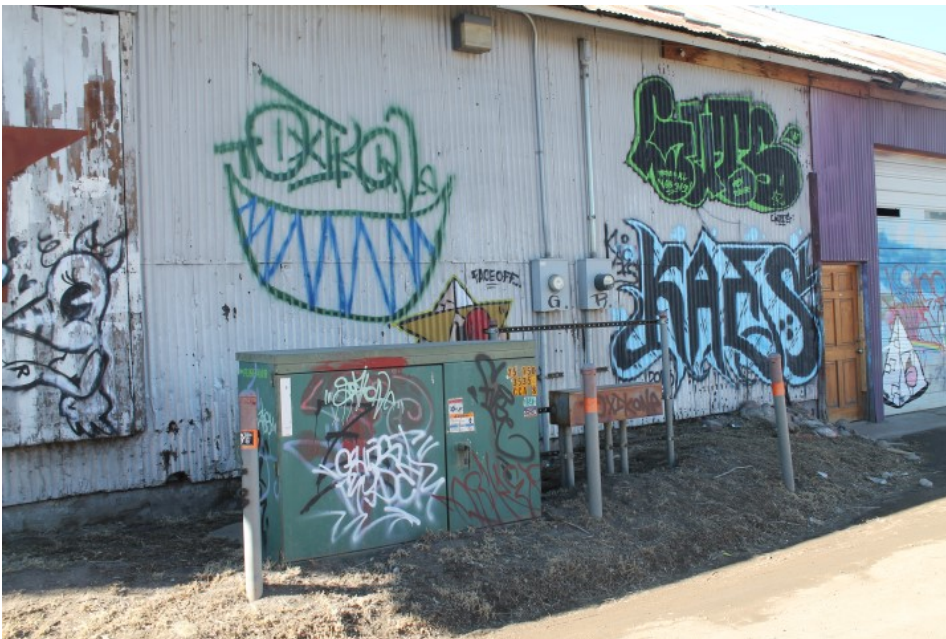
Figure 2-9 Deteriorated exterior walls, deteriorated fascia/eaves, lack of gutters/downspouts, vagrants/graffiti/vandalism (Photo C-3)

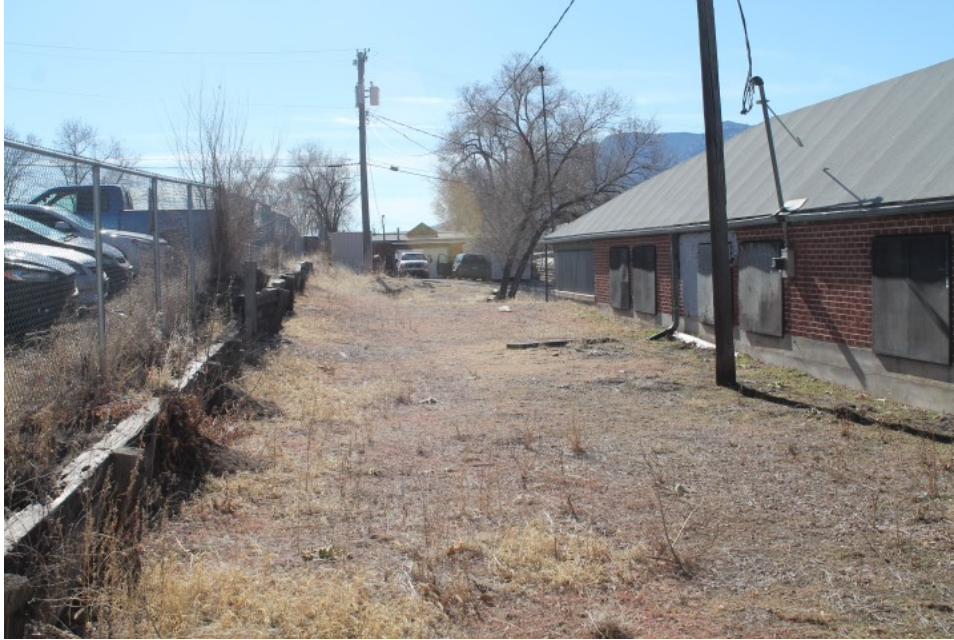
Figure 2-10 Presence of trash and debris, vagrants/graffiti/vandalism (Photo D-5)

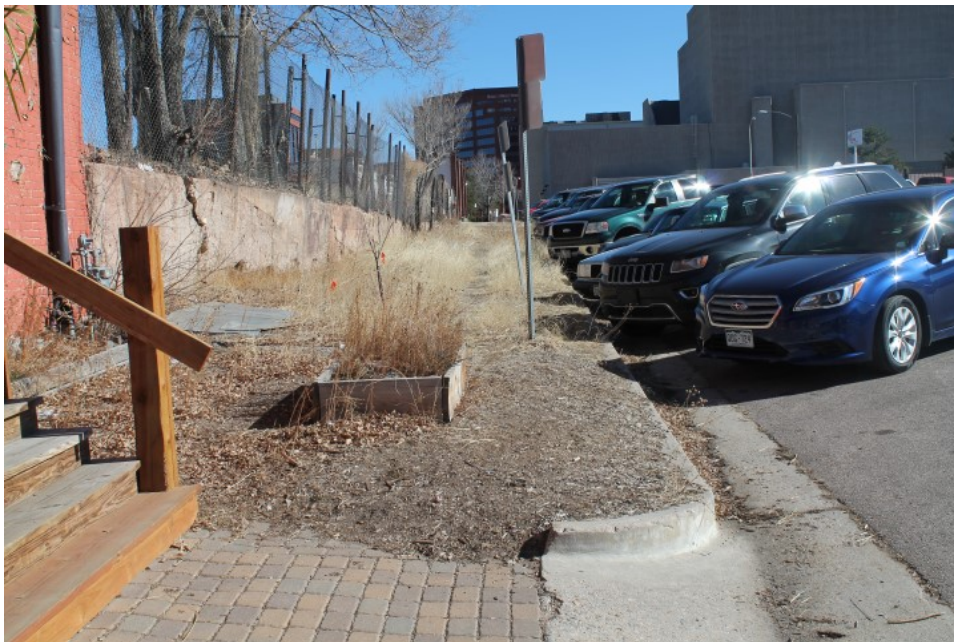
Figure 2-11 Poor vehicle access, substandard driveway/curb cuts, cracked or uneven pedestrian surfaces, unsafe level changes, inadequate and deteriorated sidewalk, presence of trash and debris, unsafe level changes, inadequate site maintenance, non-conformance to development regulations, deteriorated site walls (Photo D-10)

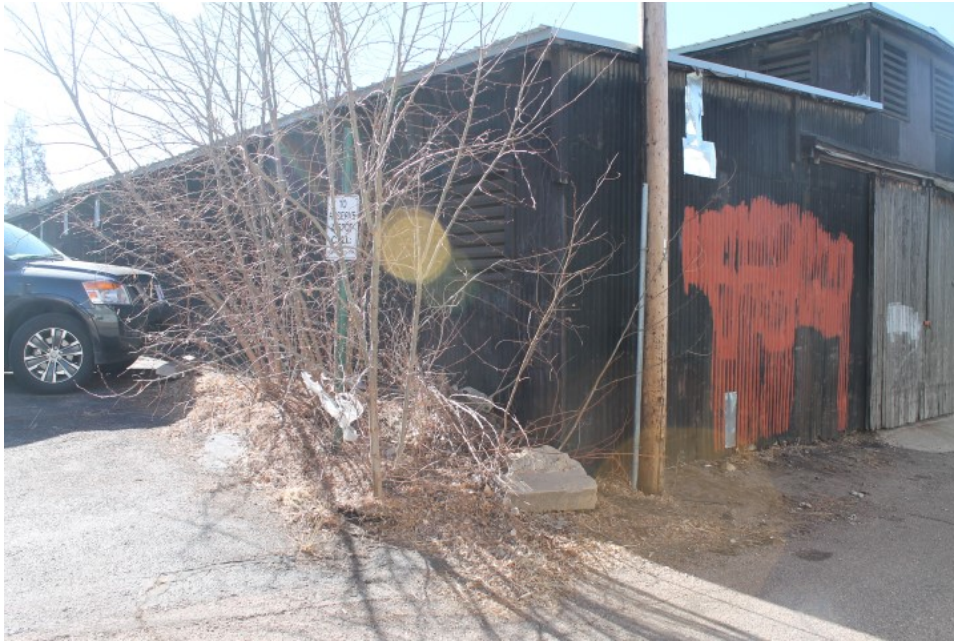
Figure 2-12 Deteriorated exterior walls, deteriorated fascia/eaves, lack of gutters/downspouts, vagrants/graffiti/vandalism, inadequate site maintenance, non-conformance to site development regulations (Photo E-1)

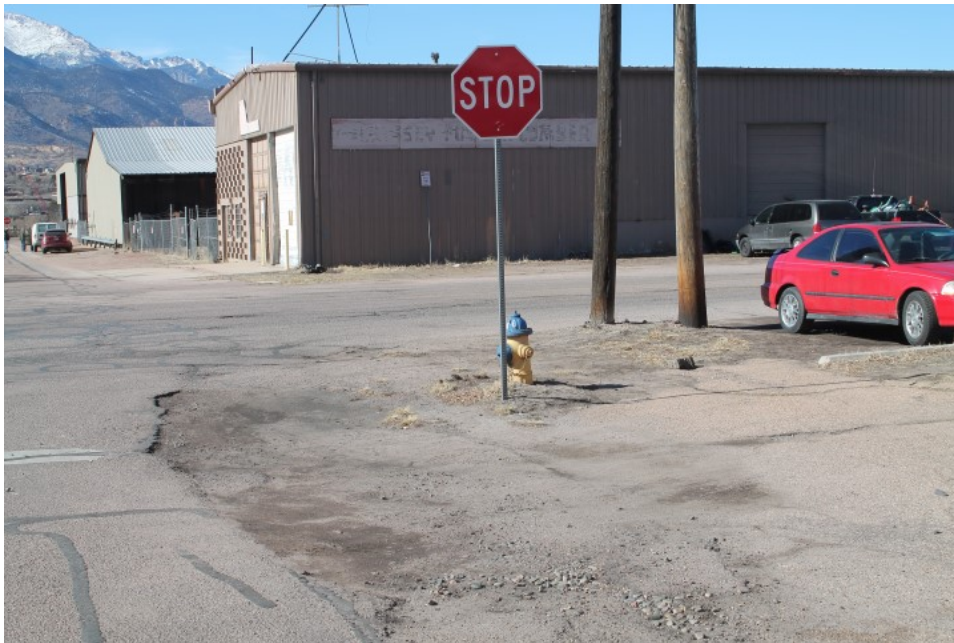
Figure 2-13 Poor vehicle access, lack of parking lot pavement, substandard driveway/curb cuts, cracked and uneven surfaces, unsafe level changes, deteriorated curb and gutter, inadequate and deteriorated sidewalk, non-conformance to development regulations (Photo E-4)
