**Conditions Study for
Tejon and Costilla Partial Block
Colorado Springs, Colorado**

DGC Consulting

FINAL
February 2018

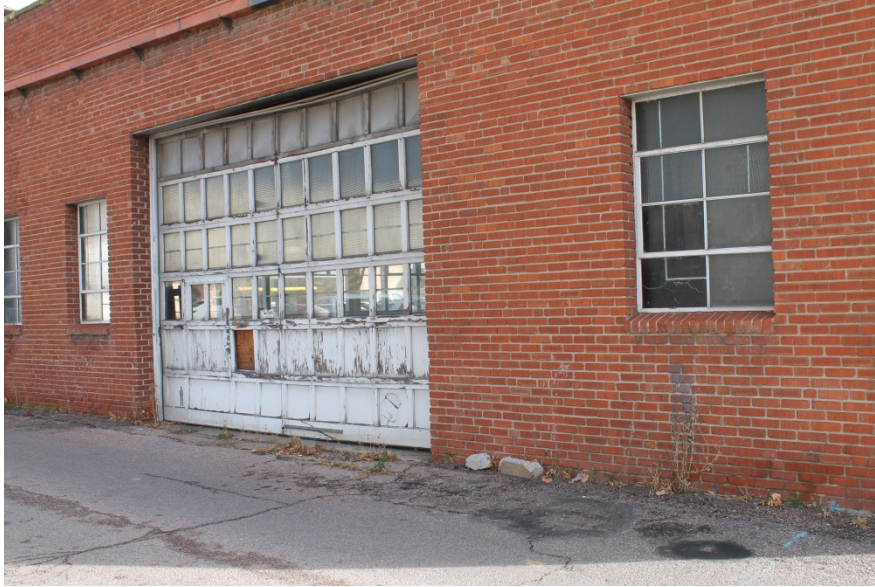
Figure 2-1 Deteriorated exterior walls and finishes; deteriorated windows and doors; deteriorated loading areas; presence of debris adjacent to structure; debris near high traffic areas; Inadequate site maintenance; non-conformance to development regulations; presence of debris next to structures (Photo 1)

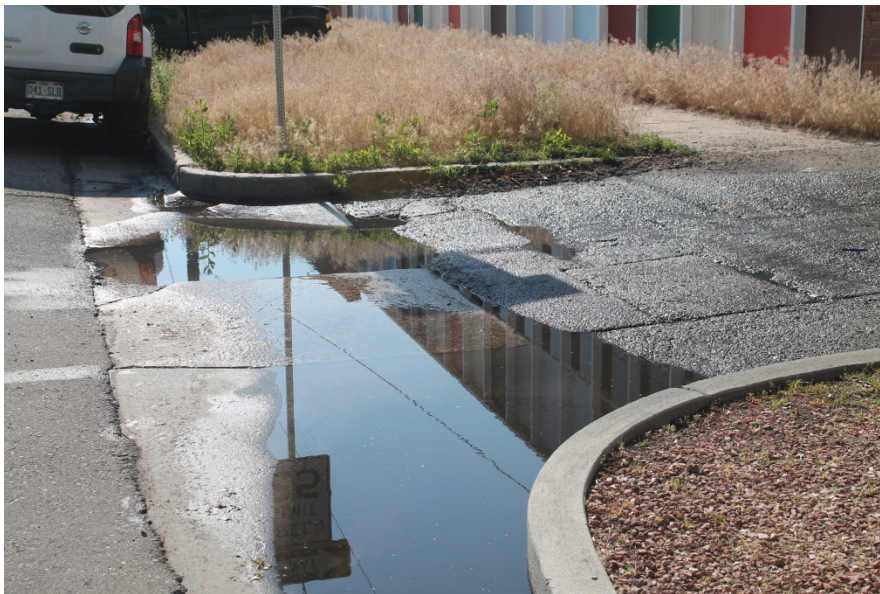
Figure 2-2 Cracked or uneven pedestrian surfaces; poor drainage; presence of trash and debris; potentially hazardous conditions; deteriorated drainage facilities; inadequate site maintenance; non-conformance to development regulations; debris near structures; fire hazards near structures; dead shrubs near high traffic areas; (Photo 2)

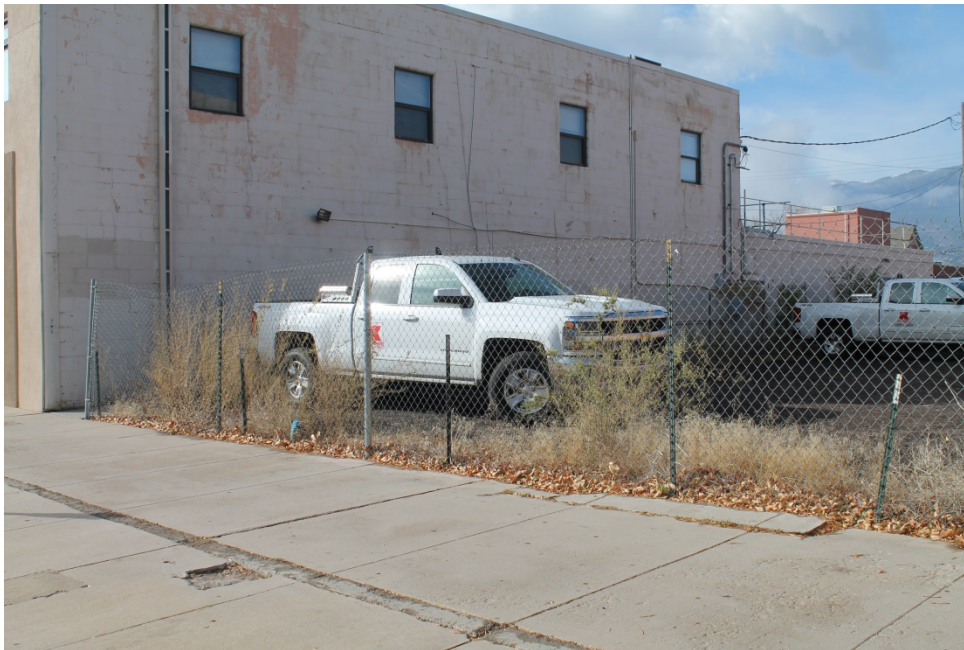
Figure 2-4 Deteriorated walls/fences; presence of trash and debris; trip/fall hazards; inadequate site maintenance; non-conformance to development regulations; deteriorated sidewalks in the right-of-way; dry debris a near structures; hazardous materials near structures (Photo 6)
