**Conditions Study for
Auditorium Block
Colorado Springs, Colorado**

Colorado Springs Urban Renewal Authority (CSURA)
30 South Nevada Avenue, Suite 502
Colorado Springs CO 80903

DGC Consulting

DRAFT
March 2018

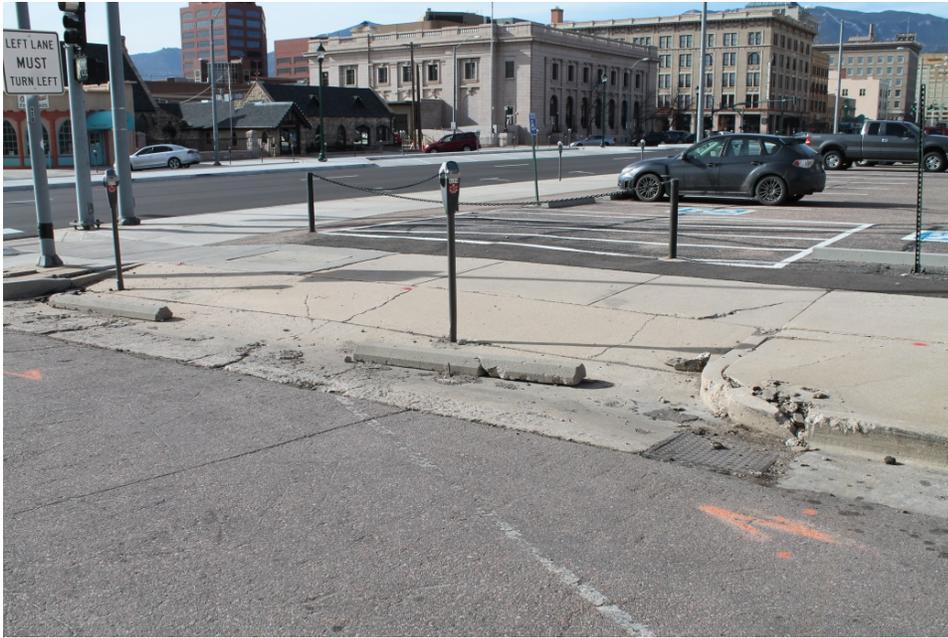
Figure 2-1 Poor vehicle access; substandard driveway definition; cracked or uneven pedestrian surfaces; insufficient grading; presence of trash and debris; potentially hazardous conditions; unsafe level changes; deteriorated pavement in ROW; deteriorated curb and gutter in ROW; deteriorated sidewalks in ROW; trip/fall hazard. (Photo 1)

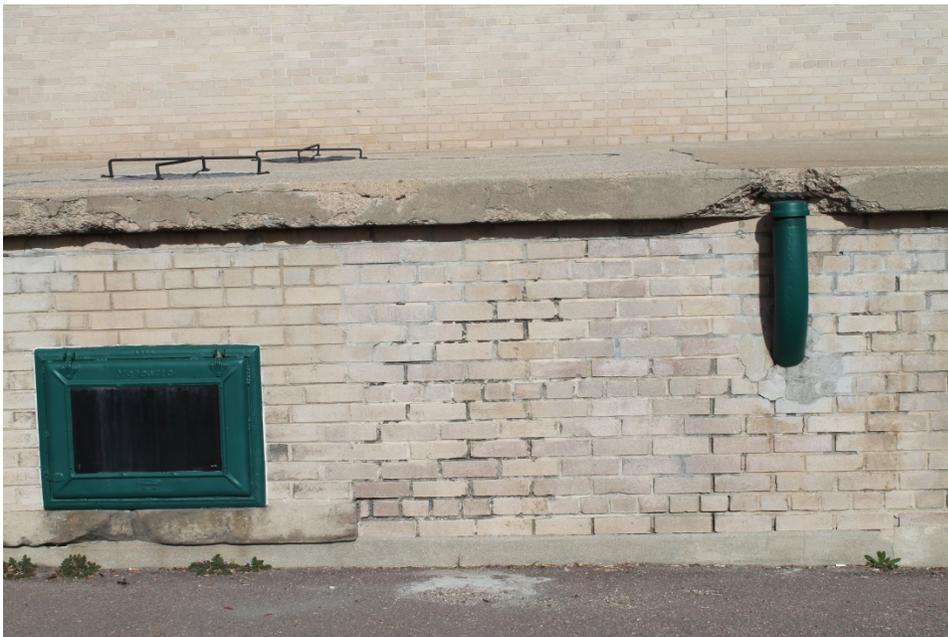
The Municipal Auditorium building had a deteriorated exterior on the south and east sides – characterized by damaged and dilapidated exterior walls, deteriorated exterior windows and deteriorated finishes. Exterior stairways, loading docks, concrete slabs, railings, and steps were also deteriorated. Much of this was due to the age of building, harsh Colorado weather, and to some degree, lack of exterior maintenance. Taken as a whole, slum, deteriorated, and deteriorating structures were observed throughout the Study Area.

Figure 2-2 Deteriorated exterior walls; deteriorated exterior finishes; inadequate site maintenance. (Photo 5)

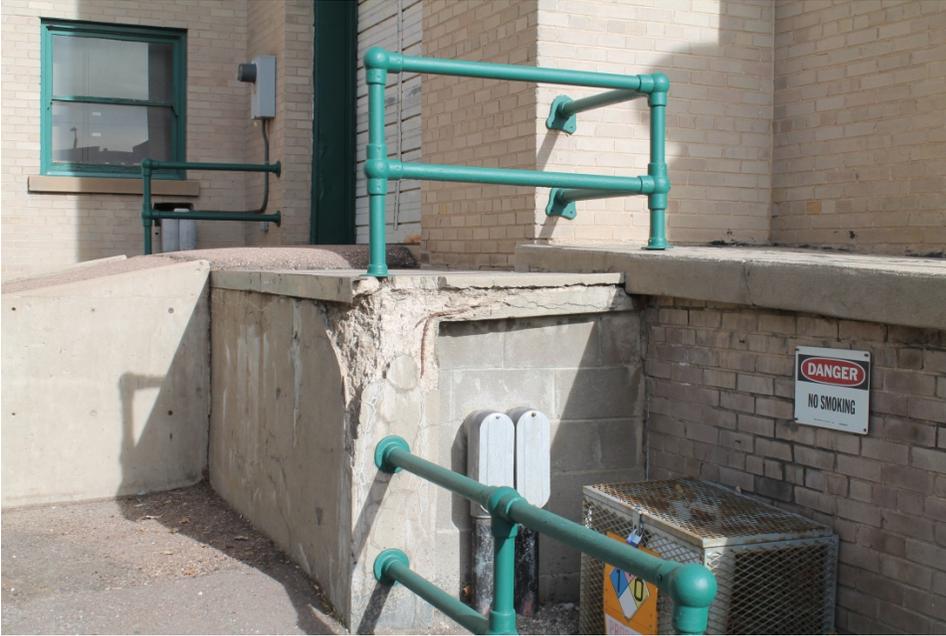
Figure 2-3 Deteriorated exterior walls; deteriorated exterior finishes; inadequate site maintenance; (Photo 6)

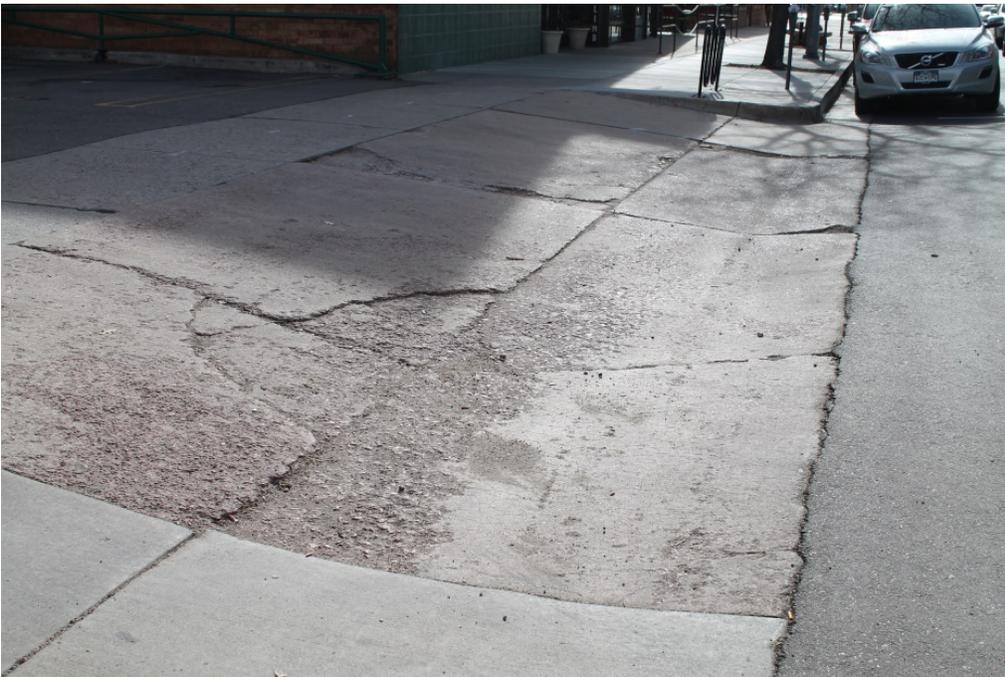
Figure 2-4 Poor vehicle access; substandard driveways; cracked or uneven pedestrian surfaces; presence of trash and debris; potentially hazardous conditions; unsafe level changes; deteriorated curb and gutter; deteriorated sidewalks; deteriorated surface drainage facilities; inadequate site maintenance; non-conformance with development regulations. (Photo 17)

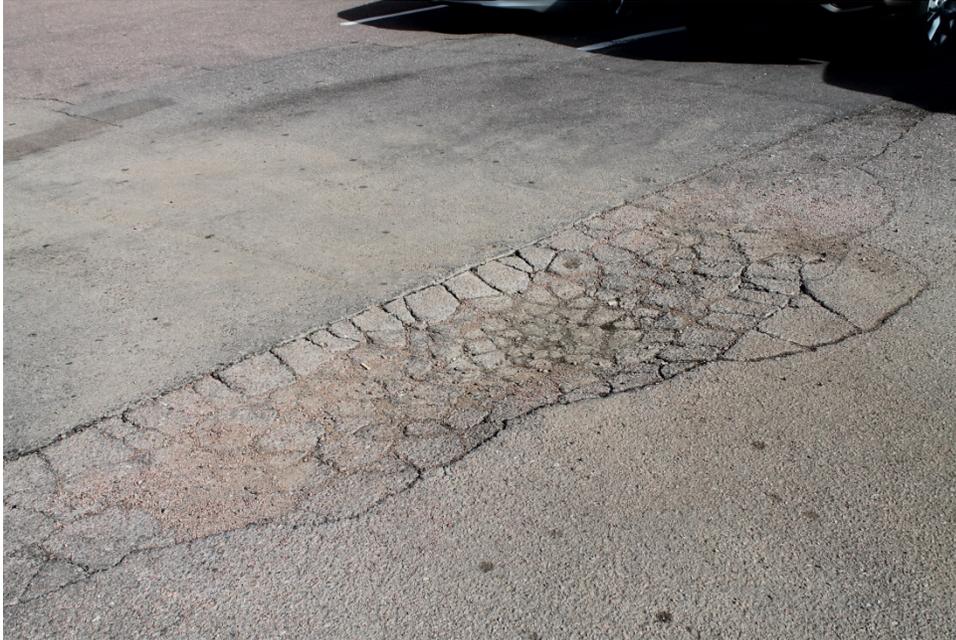
Figure 2-5 Poor drainage; unsafe level changes; deteriorated parking lot pavement; deteriorated surface drainage facilities; inadequate site maintenance; non-conformance with development regulations. (Photo 22)

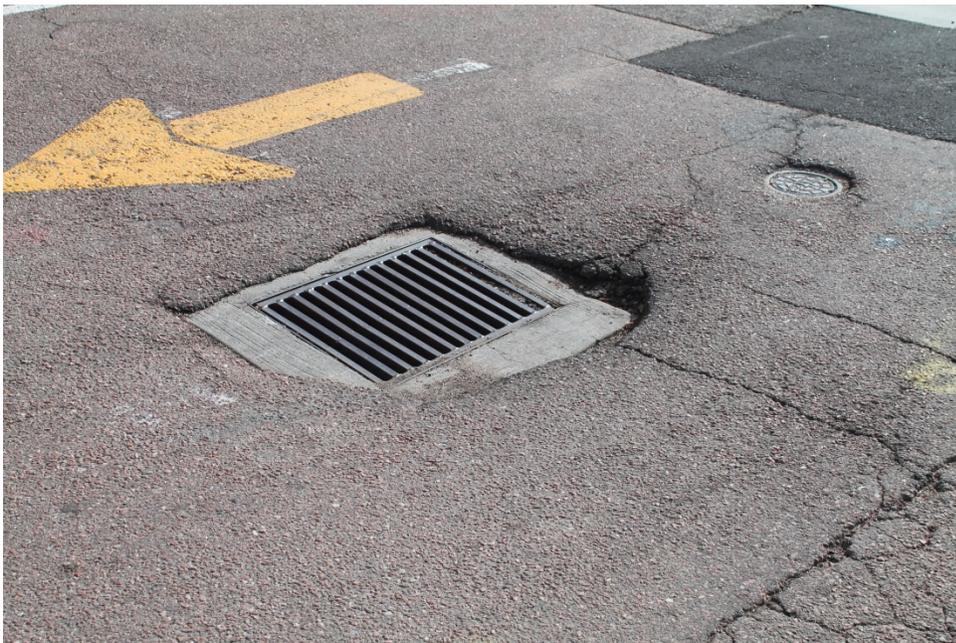
Figure 2-6 Poor drainage; unsafe level changes; deteriorated parking lot pavement; deteriorated surface drainage facilities; inadequate site maintenance; non-conformance to development regulations; unsafe level changes. (Photo 12)
