# Gold Hill Mesa Commercial Area Conditions Survey

City of Colorado Springs, Colorado

January 2015

Ricker|Cunningham  
8200 South Quebec Street, Suite A3-104  
Centennial, CO 80112

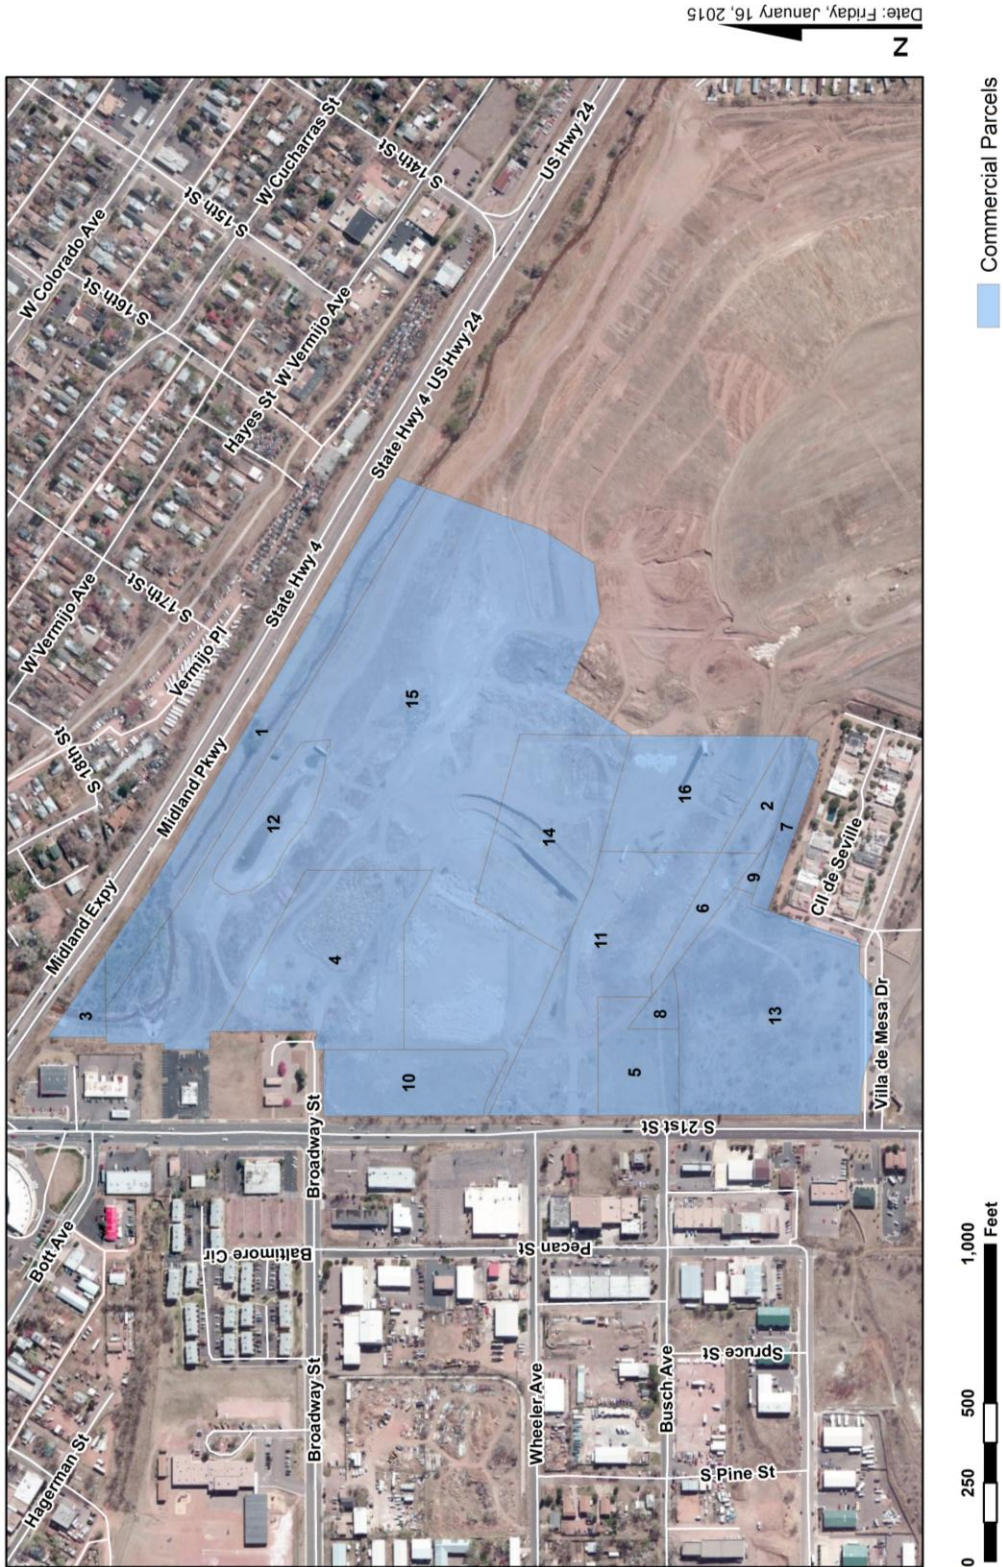
Figure 1: Survey Area Boundaries

In addition to limited access to and within the Area, other parcel-related conditions which negatively impact the ability of properties within its boundaries to develop include size and shape. As evidenced in **Figure 1**, several properties are either too small or too irregular in shape to be developed to City-standards without being part of a larger assemblage. Size relative to zoning is a particular concern whereas site coverage, density, and parking ratios are dictated by use, irrespective of parcel size, thereby rendering some properties economically "useless." Similarly, many of those parcels with an irregular shape also suffer from a significant lack of utility, rendering them unmarketable. A parcel with limited usefulness due to shape is one that when developed leaves substantial portions either under-utilized or with limited access or visibility.

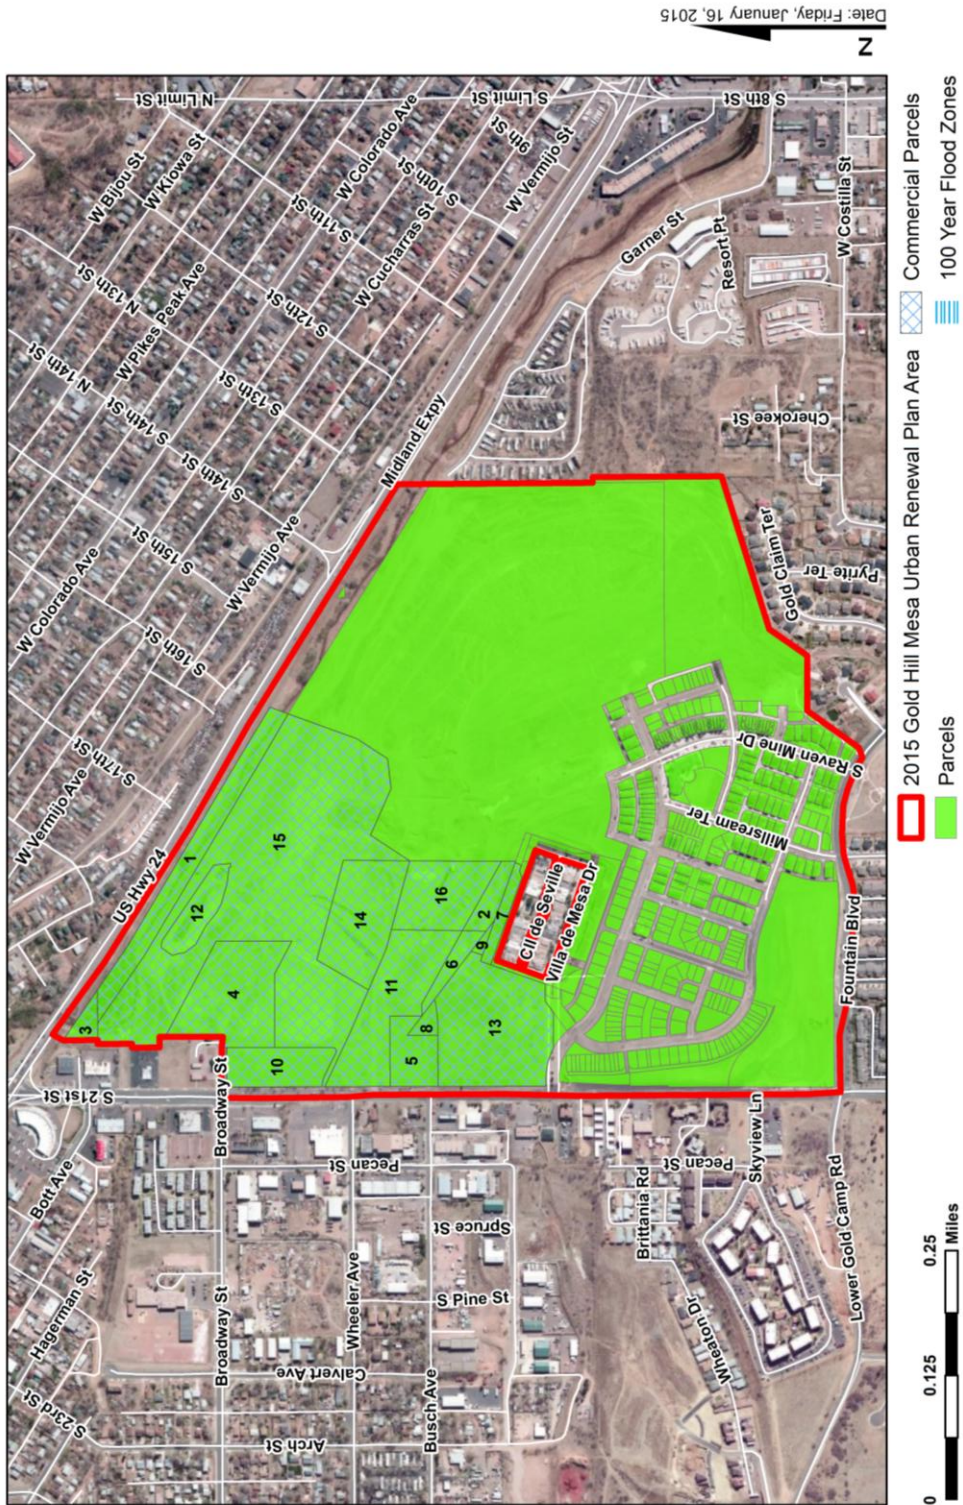
Figure 4: 100 Year Flood Zone Map

Other conditions considered in the context of this factor include steep slopes, which have already been identified, and the presence of a flood zone, high levels of criminal activity, and a lack of fire protection equipment. Despite the Area's proximity to Fountain Creek, located along its northern boundary (as depicted in **Figure 4**), no parcels in the Area are known to be impacted by a 100-year flood zone. With regard to criminal activity, according to the Colorado Springs Police Department, the number of criminal incidents in the Area between 2004 and 2011 appears to have remained fairly constant, if not declining. Finally, no information was available regarding fire protection equipment in the Area, which is not unusual since all of the subject parcels are vacant and unimproved.

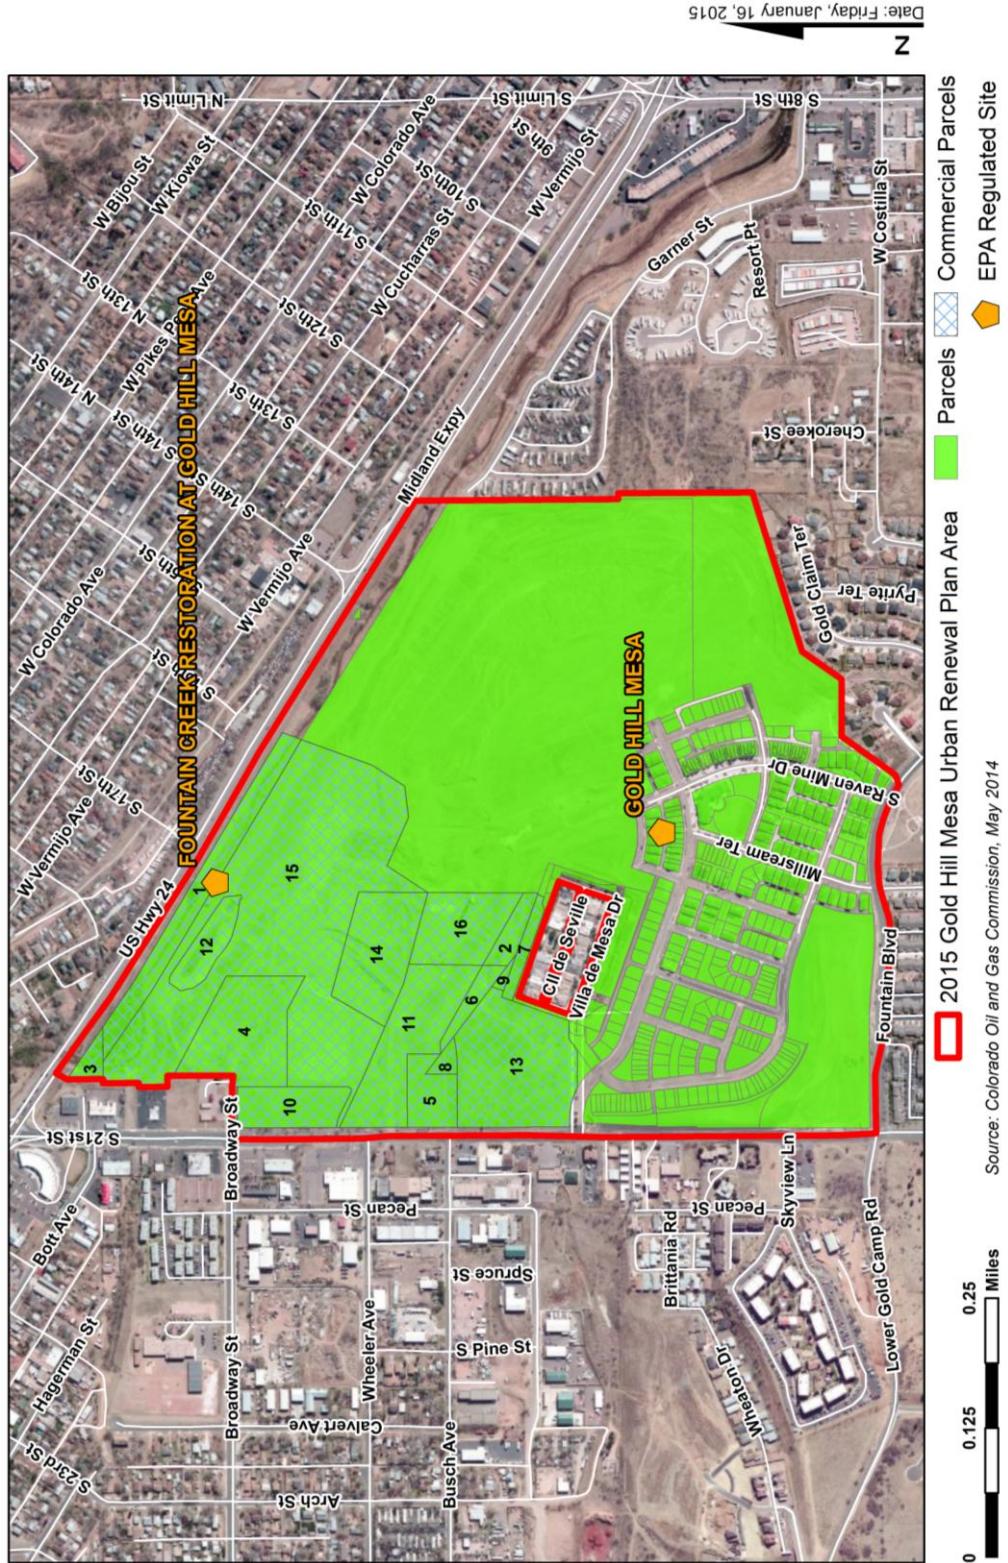
Figure 5: Facilities Subject to EPA Oversight

A review of materials published by the State of Colorado on behalf of the Federal Government related to properties that are presently under the oversight of the EPA, revealed that there are two locations under review within the existing Gold Hill Mesa Urban Renewal Area, one of which is within the Survey Area. **Figure 5** illustrates their location.

Properties within the Area and larger urban renewal area are impacted by environmental contamination stemming from the accumulation of tailings from the ore refinement process that took place at the Golden Cycle Mill from 1905 to 1949. Specifically, both lead and arsenic have been detected in the soils.
