TABLE OF CONTENTS

The following report, the *North Nevada Avenue Corridor Conditions Survey*, was completed in August 2004. The purpose of this work was to analyze conditions on all parcels located within the northern segment of the North Nevada Avenue Corridor (the Study Area) in order to determine whether factors contributing to blight are present and whether the Study Area is, therefore, eligible as an urban renewal area under the provisions of Colorado State Statutes. Establishment of an urban renewal area would allow the City of Colorado Springs, through its urban renewal authority, to use designated powers to assist in the redevelopment of properties and improvements within its boundaries.

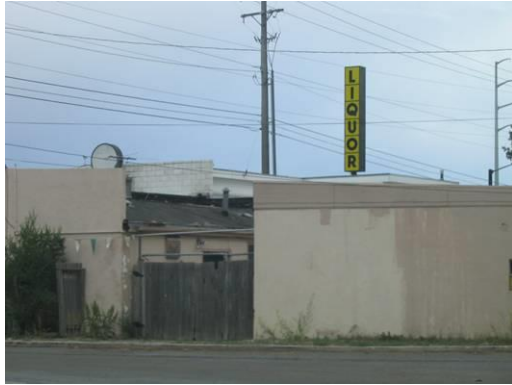
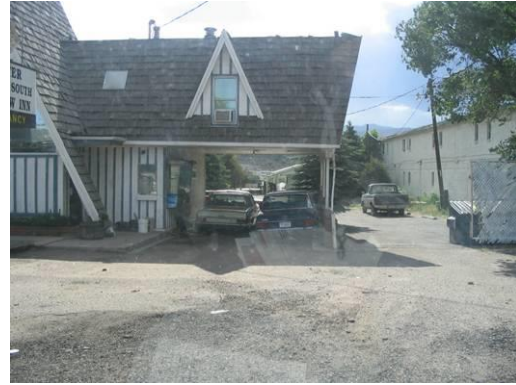
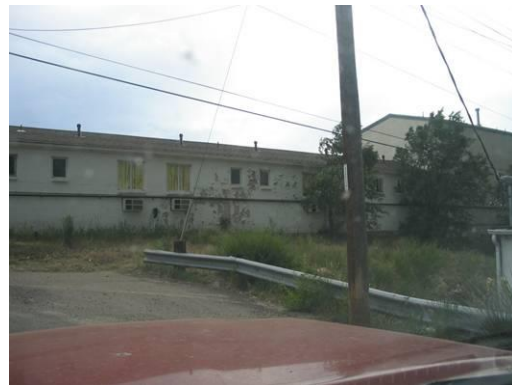
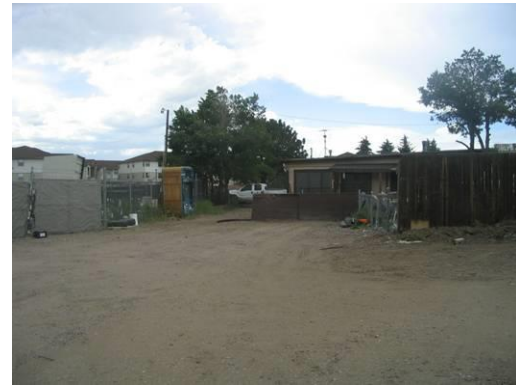
to have window, roof, and wall deterioration. Other Study Area structural problems, though less common, include deterioration of exterior walls, gutters, fences, mechanical equipment and loading areas. Examples of properties affected by Condition (a) are shown in the photos below.

Older motel and campground properties (together with their back lots) on the west side of North Nevada are the most impacted by this condition.

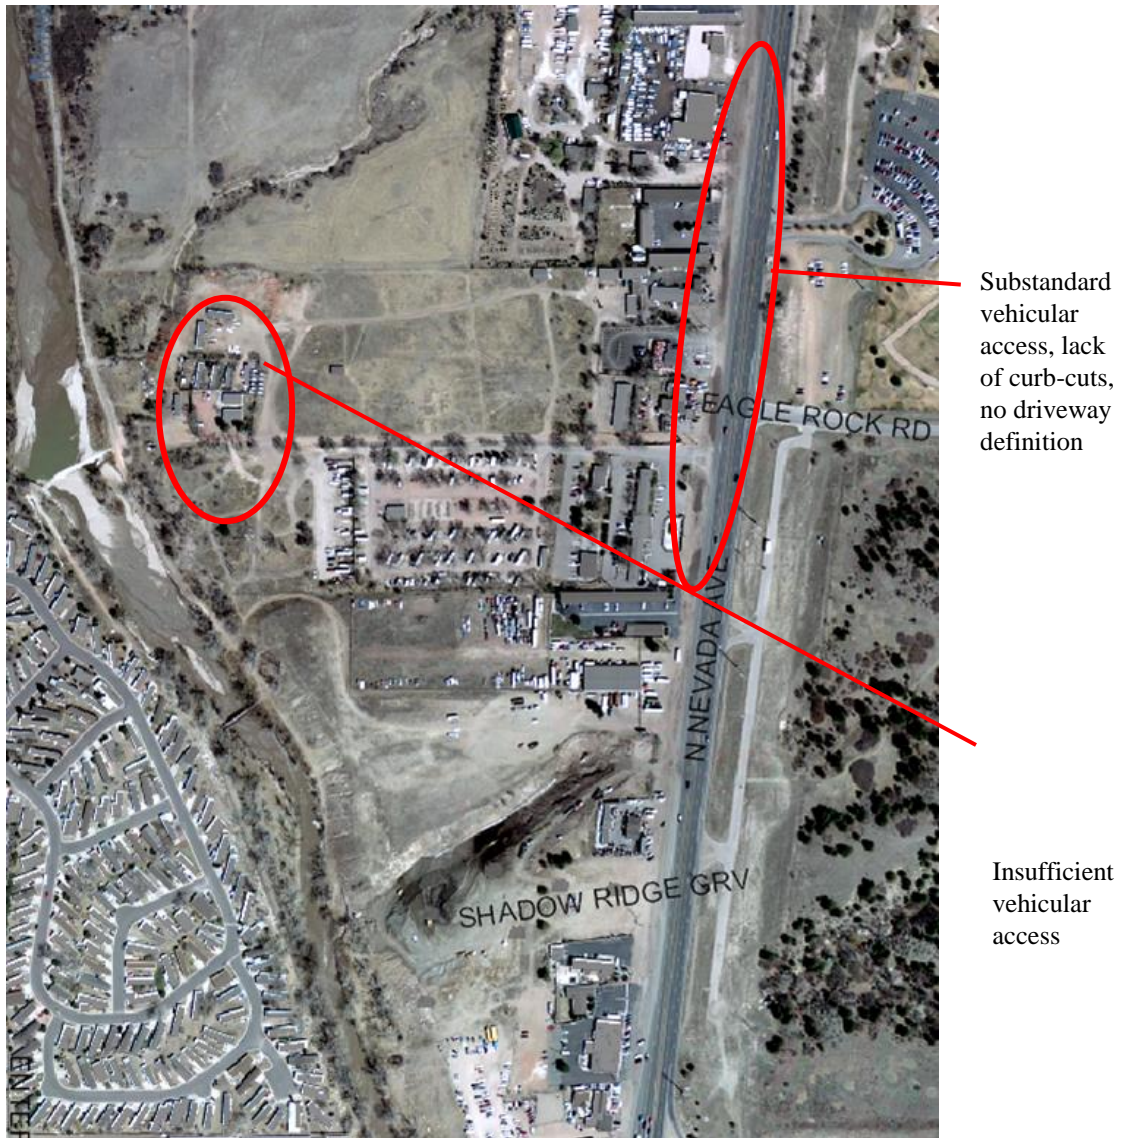
layouts in the Study Area. The most pervasive street conditions found in the Study Area were related to substandard vehicular access posed by the lack of curb cuts and driveway definitions all along North Nevada Avenue, particularly on the west and far northeast sides. In addition, several interior properties on the west side of North Nevada were not accessible at all via public streets. The aerial photograph below illustrates examples of Condition (b).

Street layout is considered faulty in cases where a parking lot is not separated from the street, not defined by curb cuts, or poses awkward entry and exit to the street. Examples of this problem can be found along all but a few properties along the west side of North Nevada Avenue, due to the wide gravel shoulder that serves as an entry and exit way between private parking lots and the public street.

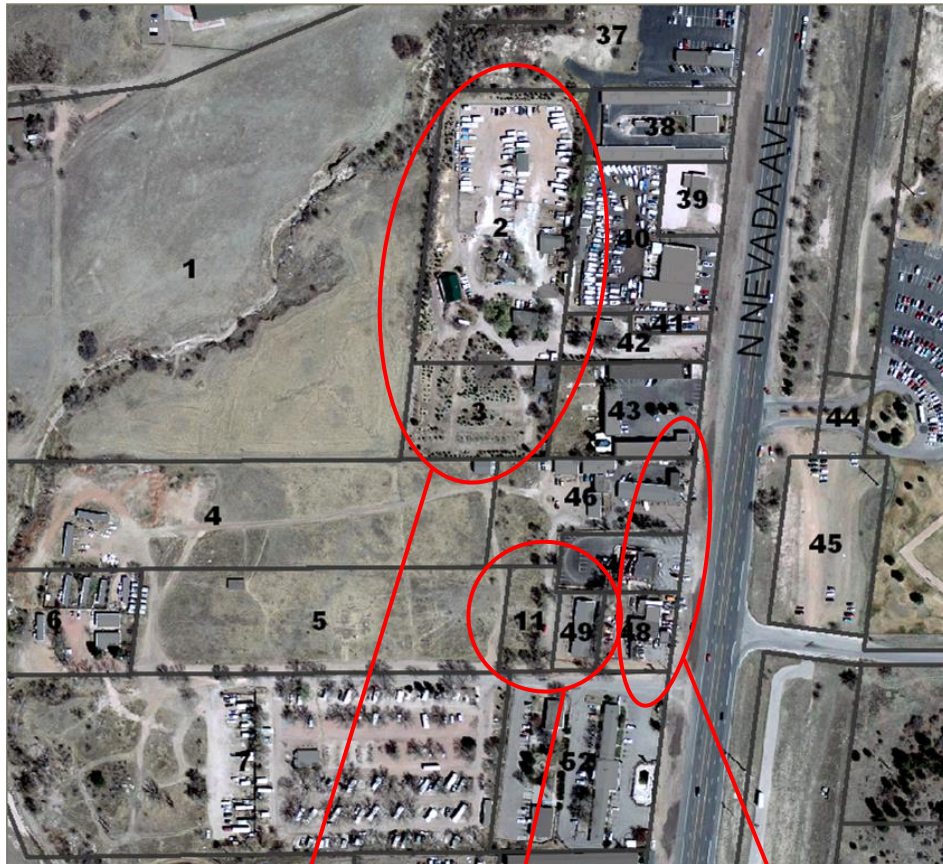
Examples of Condition (c)

Faulty lot layout
(no street frontage)

Faulty lot layout
(no street frontage),
inadequate lot size

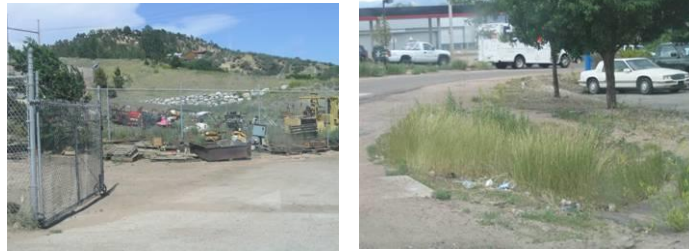
Poorly lit areas are prevalent throughout the Study Area particularly in parking lots in front of or behind older businesses along North

Nevada and in the interior parcels behind those fronting North Nevada. Problems with trash, debris and weeds can be found throughout the Study Area as well, most commonly on property around older businesses and in large vacant areas.

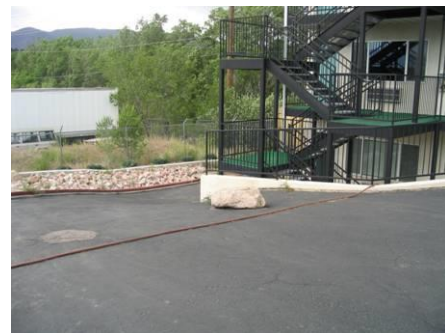
Other, less common instances of unsafe or unsanitary conditions were related to floodplain hazards and poor drainage. Some properties near Monument Creek are impacted by the 100 year flood plain. Several properties along the west side of North Nevada were also found to have poor drainage, as evidenced by substantial areas of standing water on a day following a rain shower.

Steeply sloping parking lot

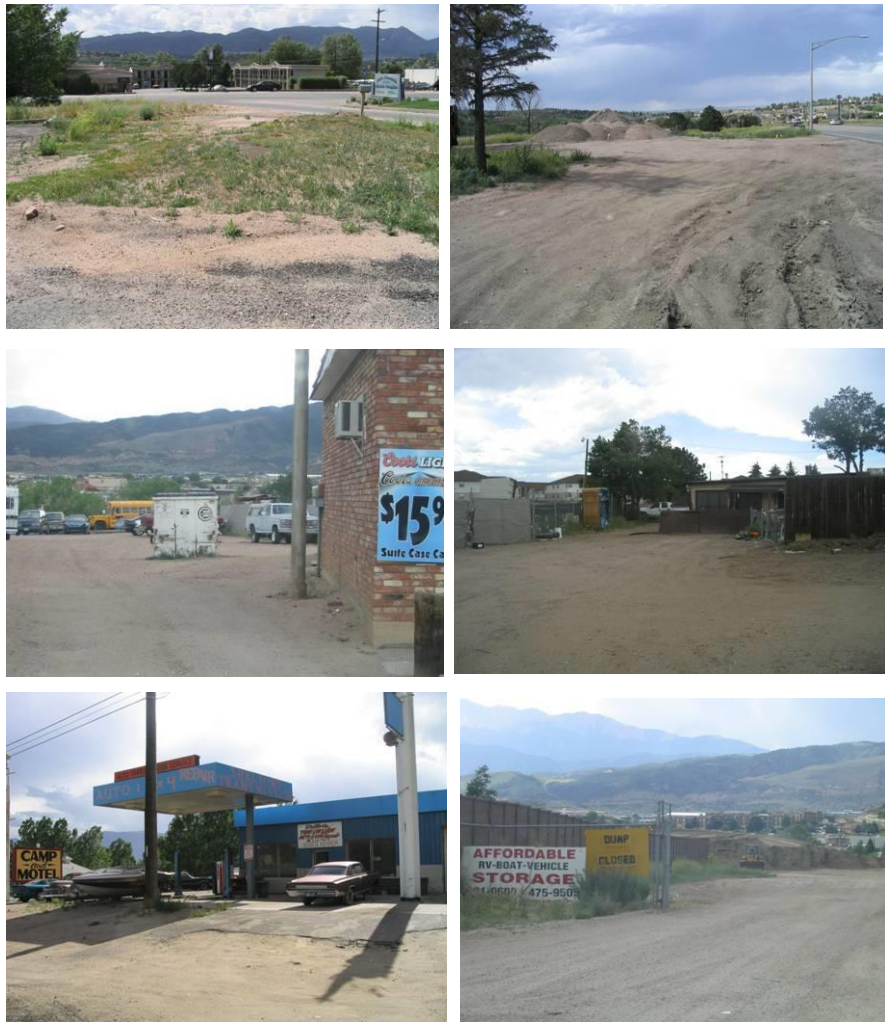
A variety of blight conditions were observed within the Study Area related to the deterioration of the site and non-primary improvements. These conditions which negatively affect the appearance and utilization of the area, most commonly include

parking surface deterioration and unscreened trash and mechanical equipment. Several sites were found to have site maintenance problems, a lack of landscaping, or signage problems. Although this condition was most prevalent along the west side of North

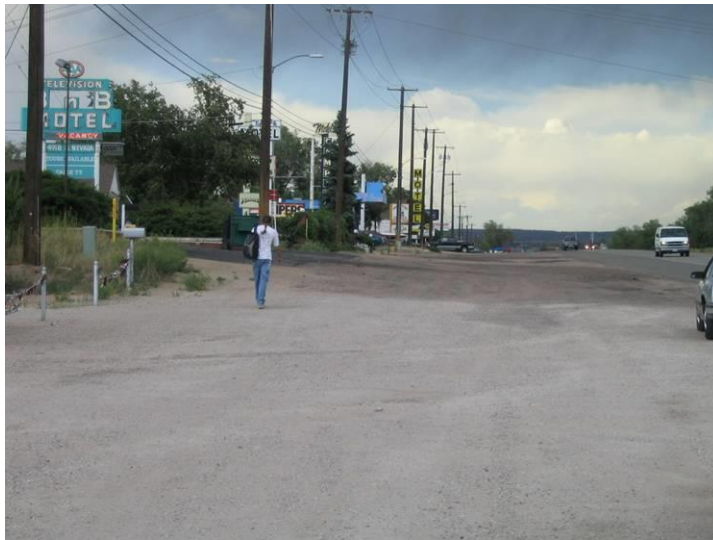
As mentioned above under Condition (d), the Study Area topography features numerous instances of steep slopes. This condition can be found on both sides of North Nevada Avenue, as shown in the maps and field inventory found in the appendix.

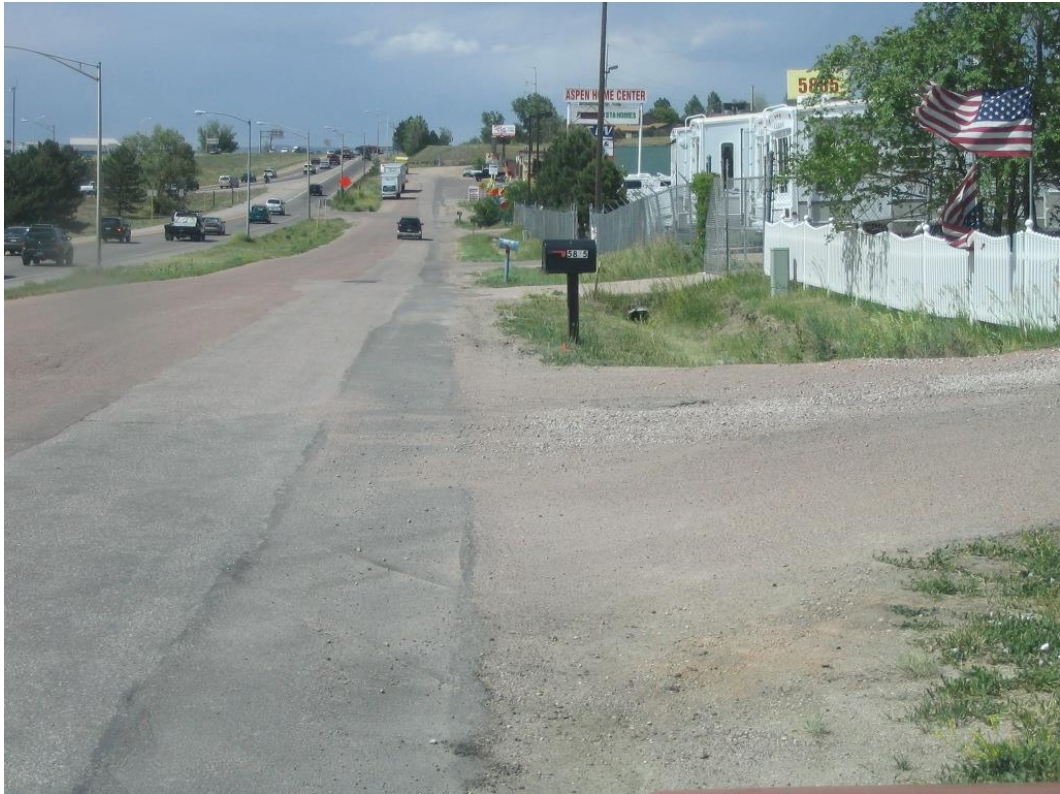
The primary conditions related to inadequate public improvements involve street pavement deterioration (especially along the west and far north east shoulders of North Nevada Avenue. Because the unit of analysis in this conditions survey is the parcel (and because public streets within the Study Area are not individual parcels) the condition of faulty street layout is referenced in the maps and tables as occurring in the adjacent parcel or parcels, rather than on the streets themselves.

Other instances of inadequate public improvements across many other parcels in the Study Area stem from the lack of adequate sidewalks or from the presence of overhead utilities. Taken together, the subcategories of inadequate public improvements can be found in every parcel within the Study Area.

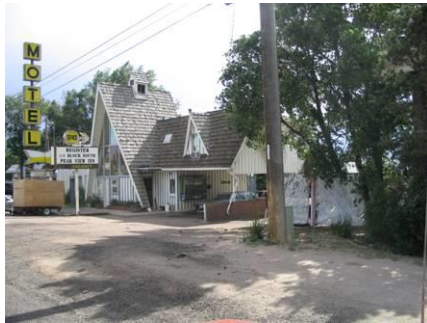
Although no interior inspections were conducted as a part of this analysis. One property, shown here, was considered sufficiently deteriorated and unsafe, based on its outside appearance, as to qualify under this condition.

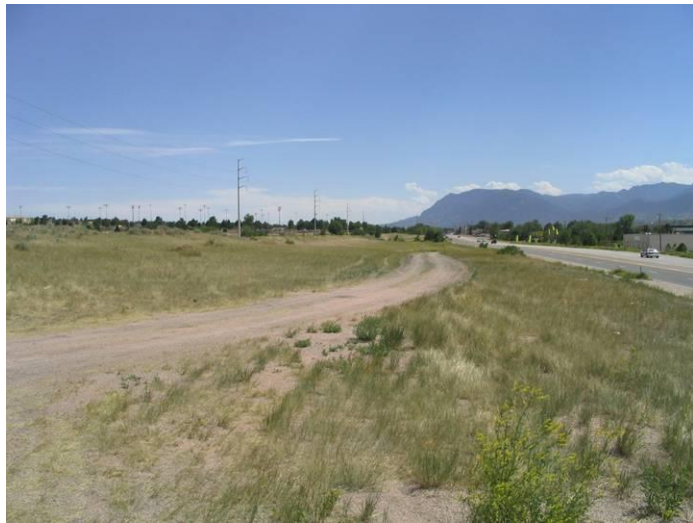
The Study Area includes 21 parcels with vacant land, a sizable portion of the total inventory. These are considered underutilized for the purposes of this analysis. Note that although the University properties on the east side of North Nevada are currently

being used as open space, they are considered underutilized for this analysis in most cases because the land is zoned to allow for higher economic uses. The other significant assemblage of vacant land is located along Monument Creek.
