SOUTHWEST DOWNTOWN COLORADO SPRINGS
BLIGHT STUDY
COLORADO SPRINGS, COLORADO

FINAL REPORT

COLORADO SPRINGS URBAN RENEWAL AUTHORITY
AND
CITY OF COLORADO SPRINGS, COLORADO

LELAND CONSULTING GROUP
694 SOUTH GAYLORD STREET • DENVER, COLORADO 80209 • (303) 458-5800

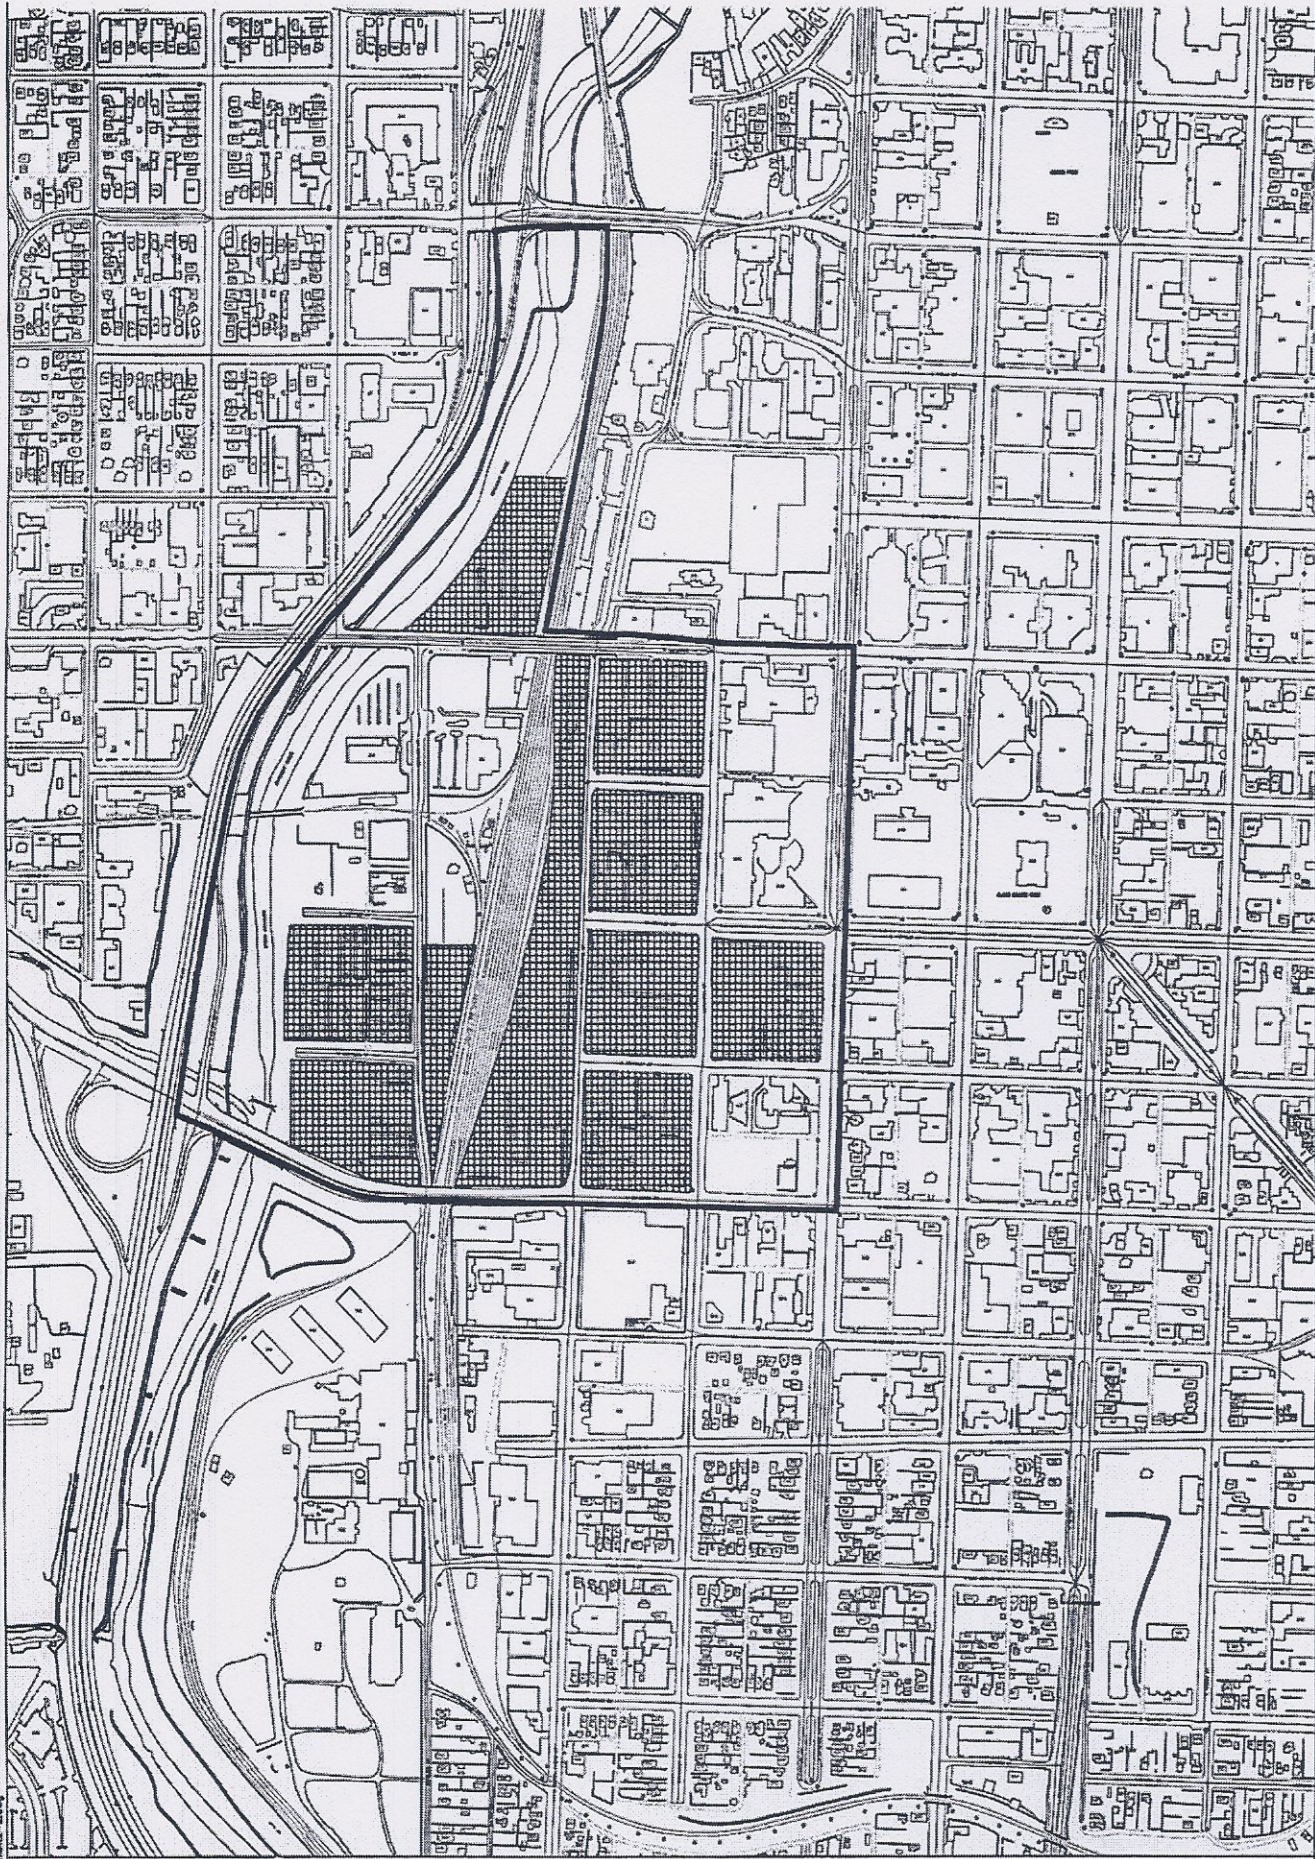
Exhibit 2: Building Deterioration

The area west of the Union Pacific railroad tracks and east of I-25 exhibited the most severe signs of building deterioration. This area also includes many abandoned properties. There were problems with both primary and secondary building structures, the most prevalent of which related to deterioration of foundation, problems with fascia/soffits, gutters/downspouts, exterior finishes and windows/doors. In the northern portion of the Study Area, there were some instances of deterioration associated with walls, gutters and downspouts, and exterior finishes.

In summary, the analysis determined that there were instances of blight related to conditions of building deterioration occurring throughout the Study Area as a whole. Exhibit 2 - Building Deterioration summarizes these instances of blight qualifying conditions within the Study Area.

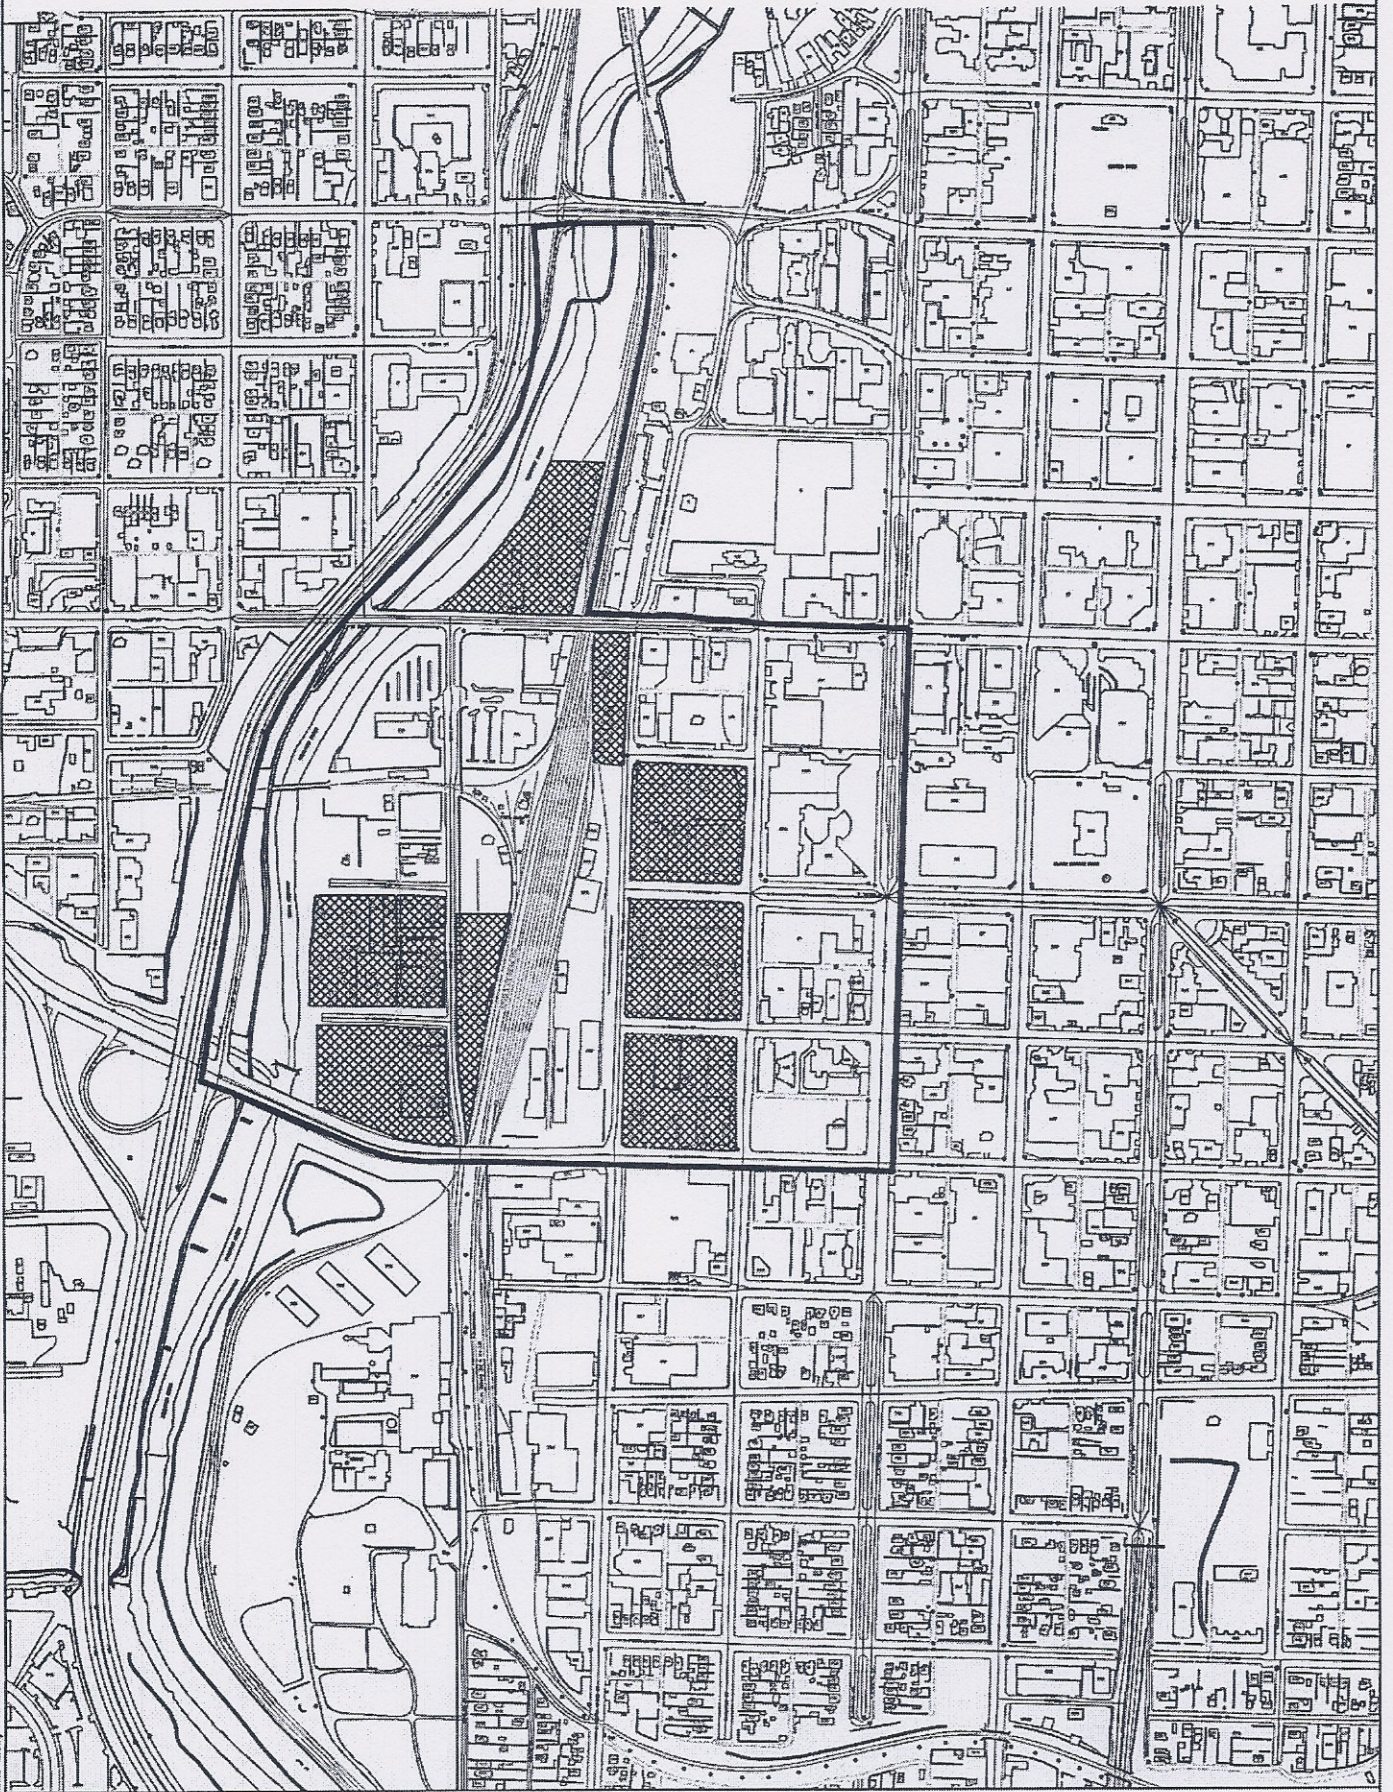
In summary, the analysis determined that there were instances of blight related to conditions of faulty street layout occurring throughout the Study Area as a whole. Exhibit 3 - Faulty Street Layout summarizes these instances of blight qualifying conditions within the Study Area.

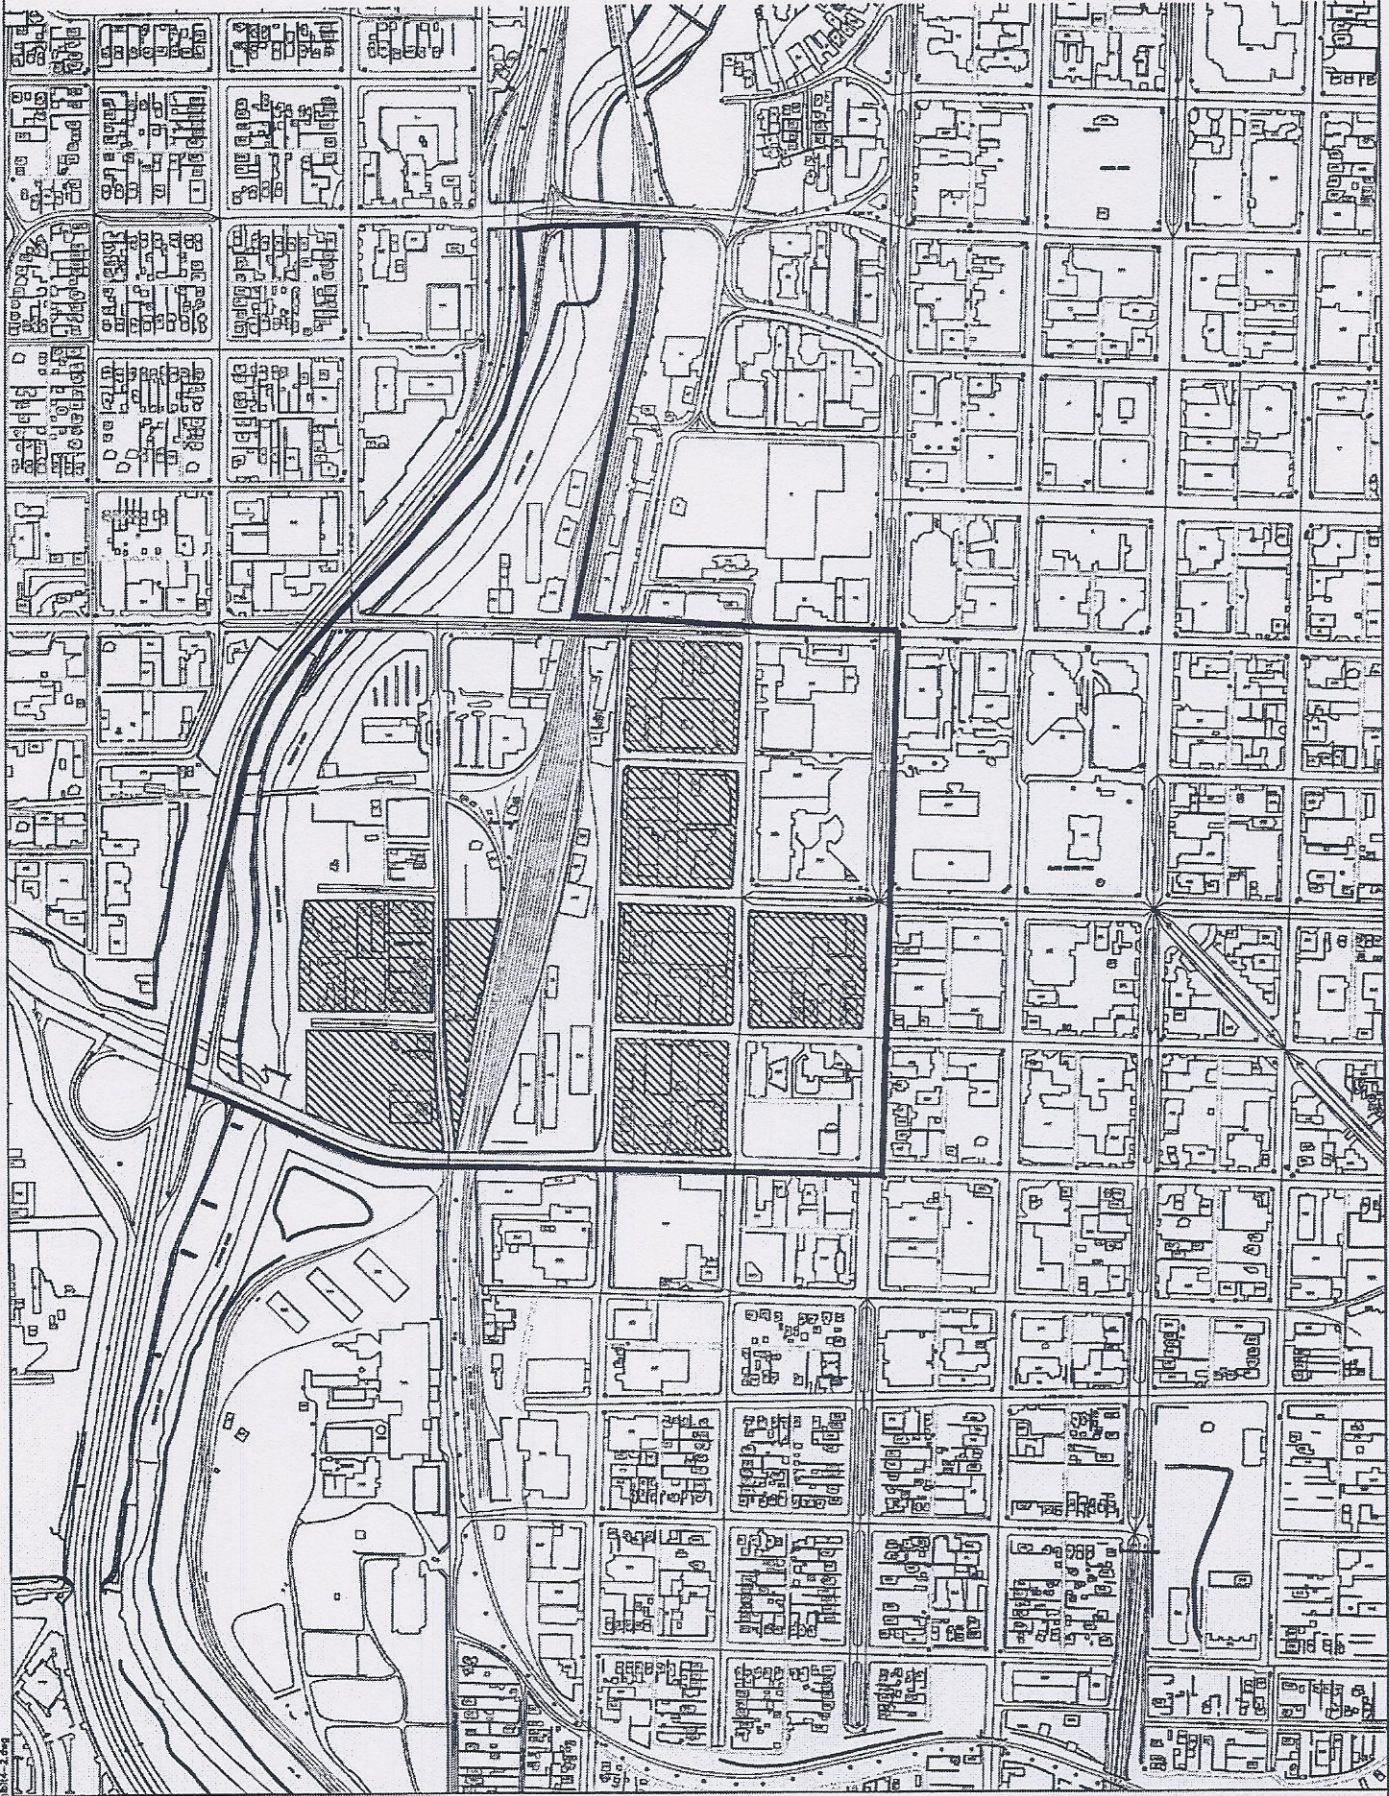
Exhibit 4: Unsanitary or Unsafe Conditions

In summary, the analysis determined that there were instances of blight related to unsanitary or unsafe conditions occurring throughout the Study Area as a whole. Exhibit 4 - Unsanitary or Unsafe Conditions summarizes these instances of blight qualifying conditions within the Study Area.

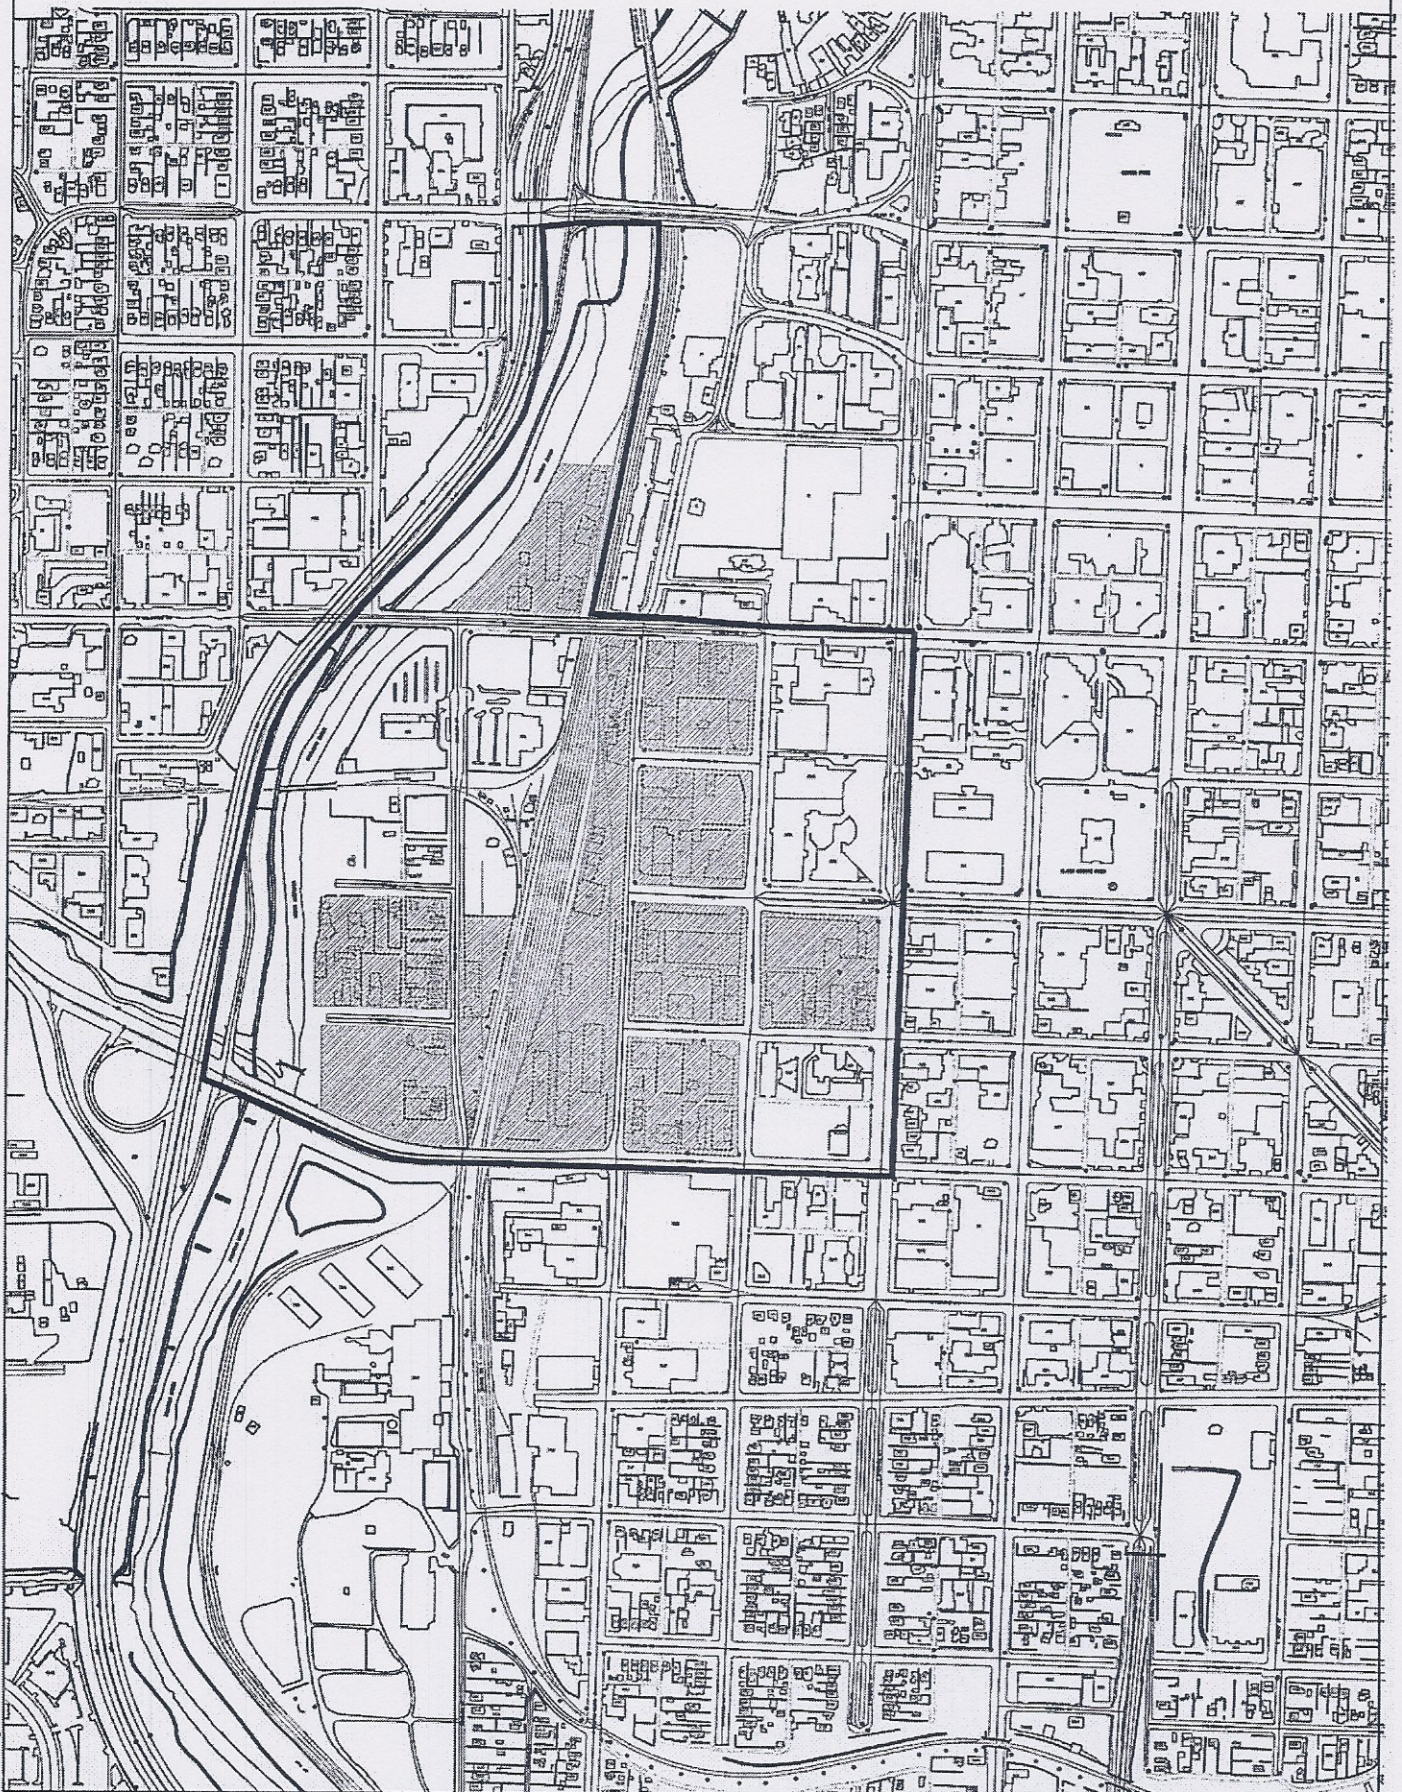
In summary, the analysis determined that there were instances of blight related to substandard improvements and conditions occurring throughout the Study Area as a whole. Exhibit 5 - Substandard Improvements and Conditions summarizes these instances of blight qualifying conditions within the Study Area.

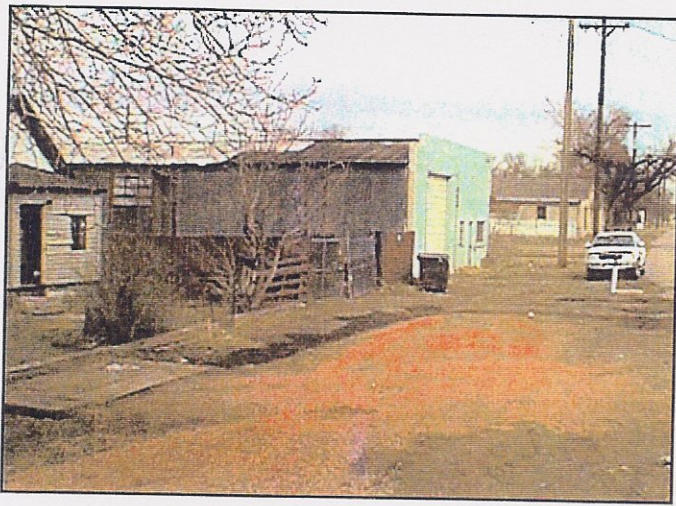
Example of "Slum, deteriorated, or deteriorating structures"; "unsanitary or unsafe conditions", and; " buildings that are unsafe or unhealthy..." factors a,, d and h.

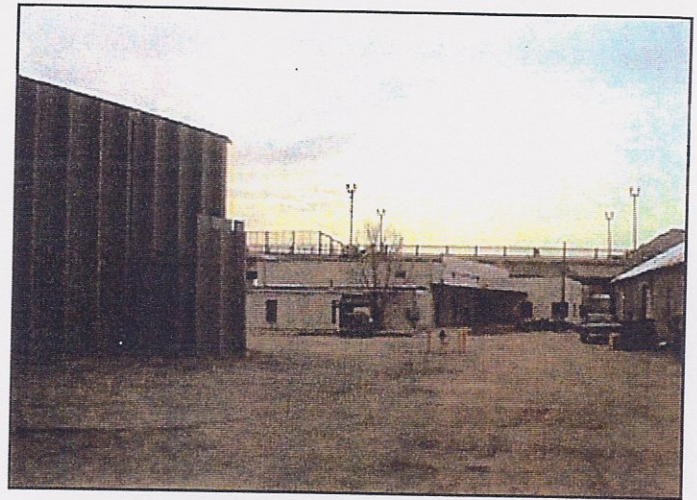
Example of "Deterioration of site or other improvements;s, and; Inadequate public improvements." factors a,e and j.

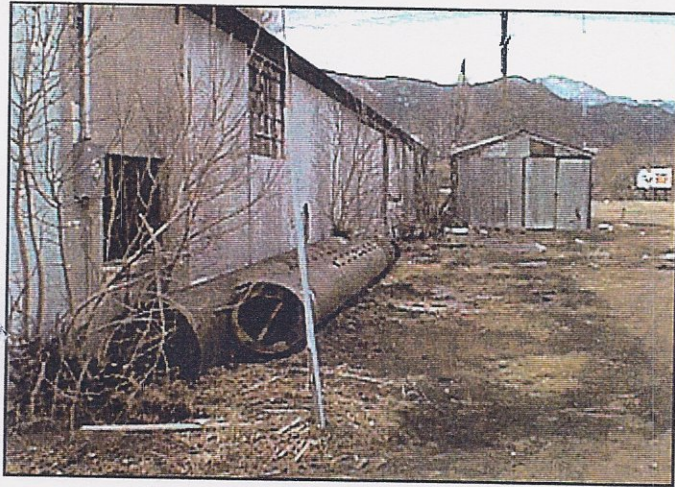
Example of "Slum, deteriorated, or deteriorating structures"; "unsanitary or unsafe conditions", and; " buildings that are unsafe or unhealthy..." factors a and h.

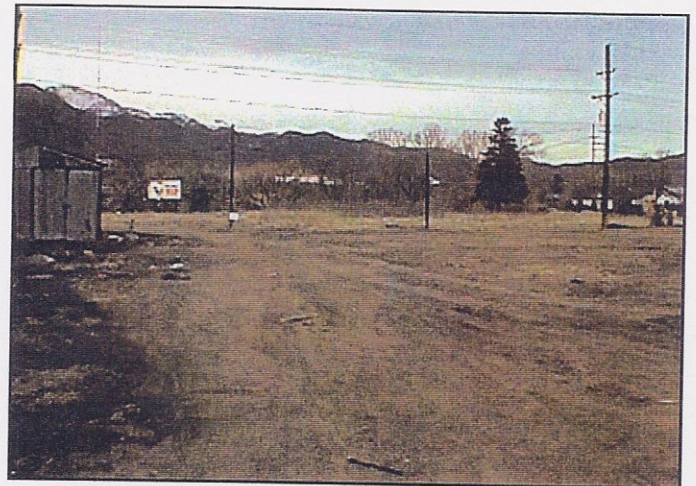
Example of "Deterioration of site or other improvements;s, and; Inadequate public improvements" factors a and j.

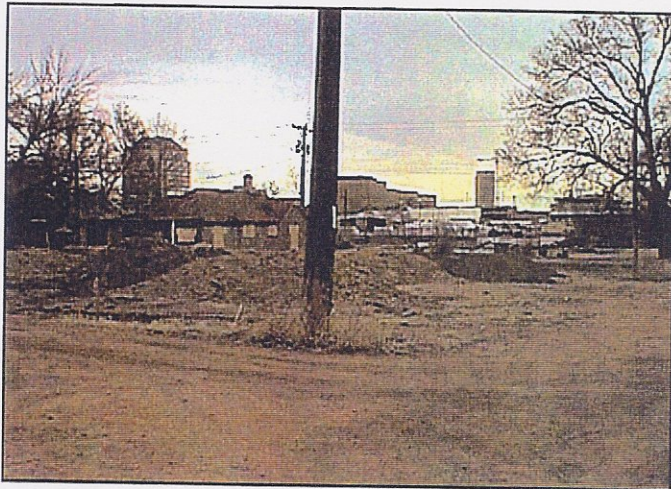
Example of "Deterioration of site or other improvements;s, and; Inadequate public improvements." factors a and j.

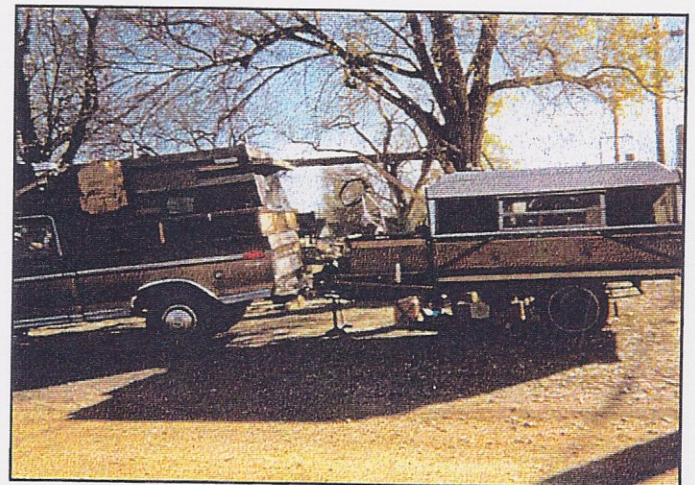
Example of "Deterioration of site or other improvements;s, Predominance of defective street layout, and; Inadequate public improvements." factors e and j.

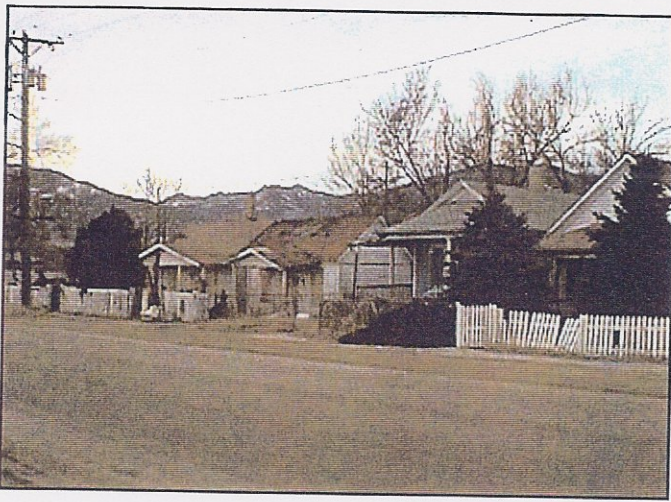
Example of "Slum, deteriorated, or deteriorating structures"; "unsanitary or unsafe conditions", and; " buildings that are unsafe or unhealthy..." factors a, d and h.

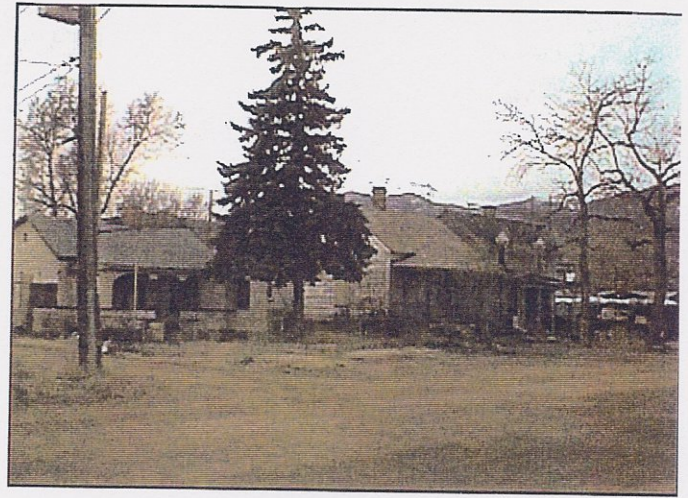
Example of "Slum, deteriorated, or deteriorating structures"; "unsanitary or unsafe conditions", and; " buildings that are unsafe or unhealthy..." factors a, d and h.

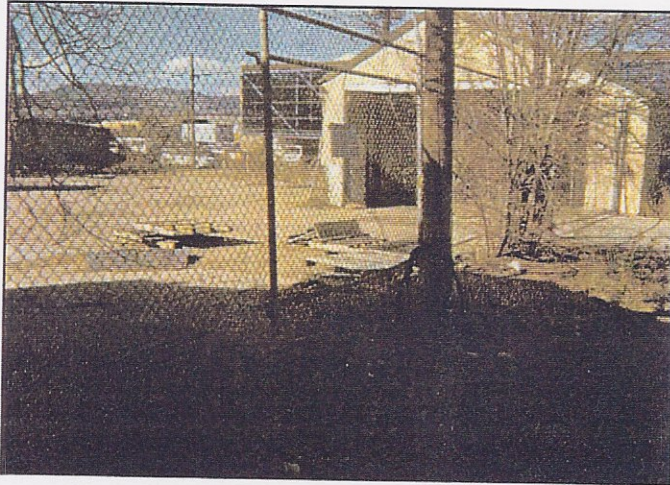
Example of "Slum, deteriorated, or deteriorating structures"; "unsanitary or unsafe conditions", and; " buildings that are unsafe or unhealthy..." factors a, d and h.

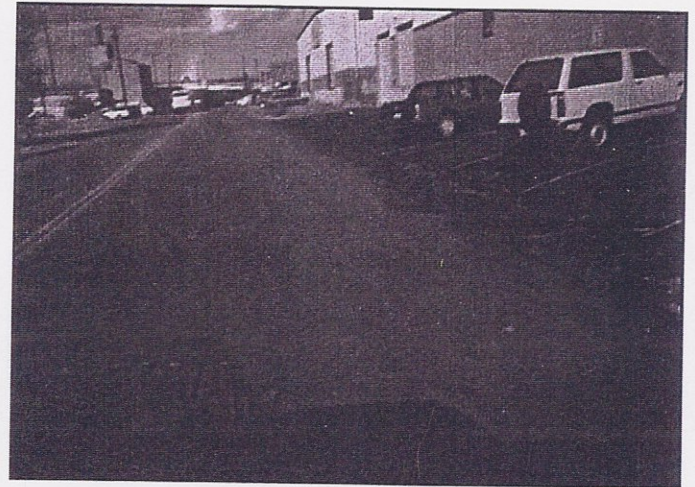
Example of : "...inadequate street layout; "Faulty lot layout"; "unsanitary or unsafe conditions", and; " Inadequate public improvements; factors b, c, d and j.

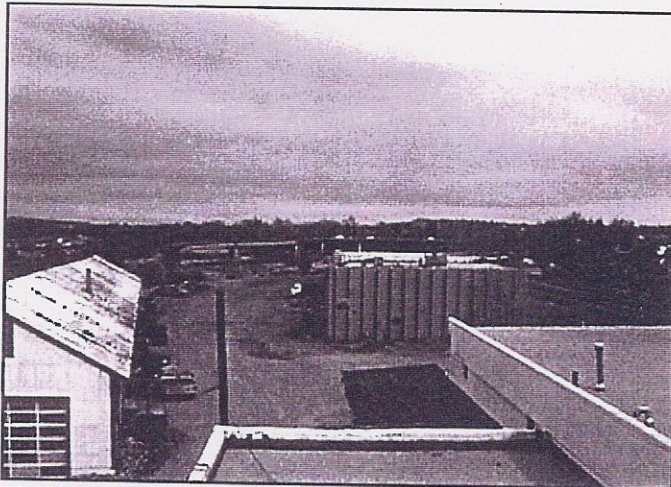
Elevated view of portion of area showing topography of floodplain, rail lines, industrial uses and buildings. Note lack of street system and bldg.. deterioration.

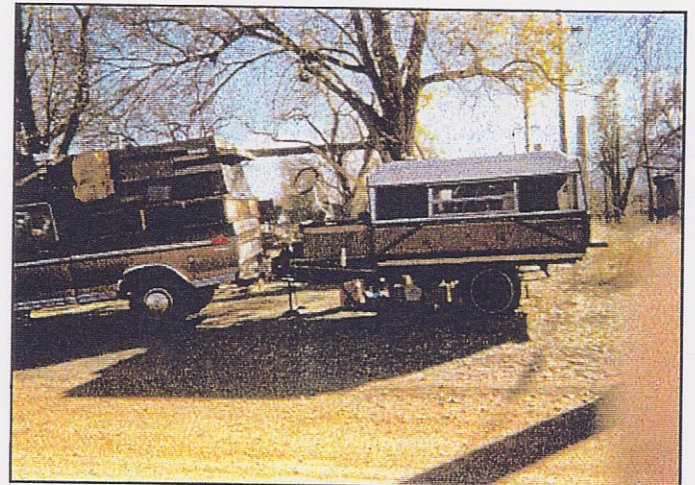
Squatters have settled in the area living in unsanitary or unsafe conditions", and; potentially adding to the crime problem.
