Draft Report

O'Neil Existing Conditions Survey

City of Colorado Springs Urban Renewal Authority

August 19, 2022

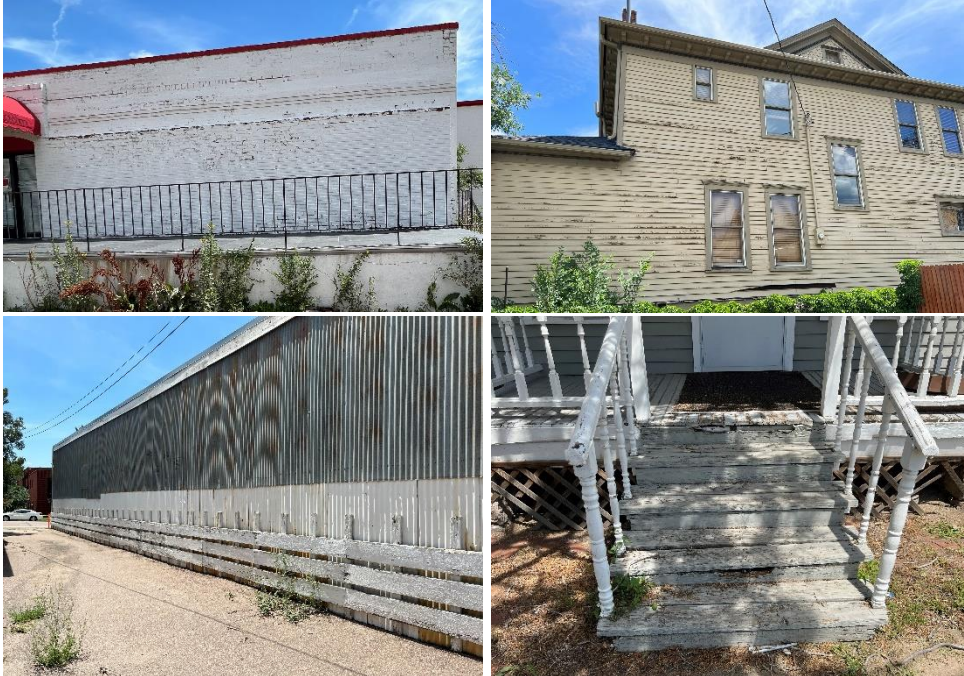
Figure 2. Deteriorated Exterior Finishes and Stairways

Multiple buildings in the Study Area have deteriorated exterior finishes with chipped paint, exposed brick, and rusted and worn-out metal siding, shown in **Figure 2**. The single family home on Parcel 3 has a deteriorated wooden stairway to the front porch as well as chipped paint.

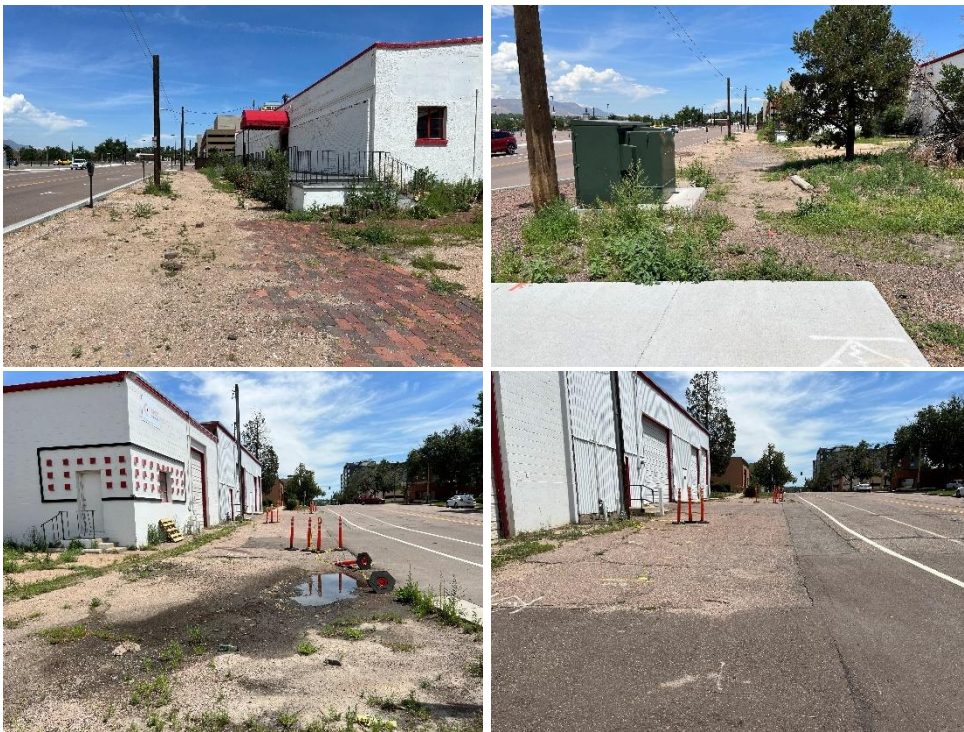
Figure 3. Poor Provision of Street Improvements for Pedestrians

Poor provisions of street improvements for pedestrians were observed in the form of lack of sidewalks along Sahwatch Street on parcel 1 and along Costilla Street on parcels 1 and 2, as shown in **Figure 3**. Along Sahwatch Street there is a defined curb but no sidewalk and along Costilla Street there is dirt and a large driveway for commercial vehicles. It is important to note at the corner of Sahwatch and Costilla Street pedestrian improvements were made with curb cuts and a small portion of sidewalk. These are extensions of the sidewalk improvements on the opposite sides of the streets and illustrates the disconnect the Study Area has within the existing pedestrian network.

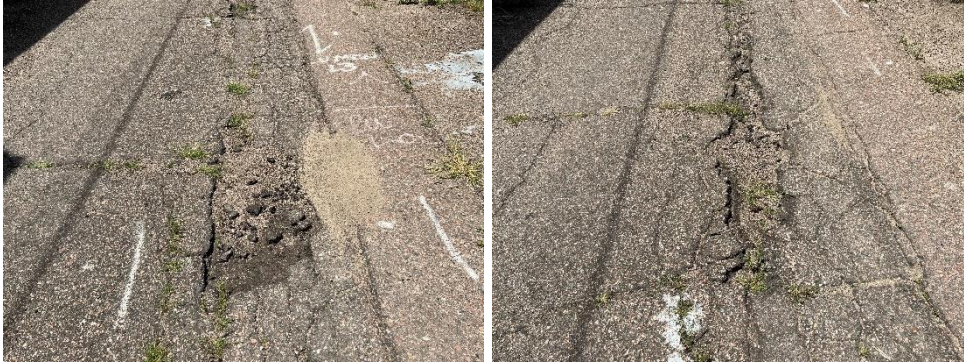
Figure 4. Poor Provision of Street Improvements for Vehicles

Additionally, poor provisions of street improvements for vehicles were observed in the form of potholes and cracked pavement in the alley on the northside of the Study Area, shown below in **Figure 4**.

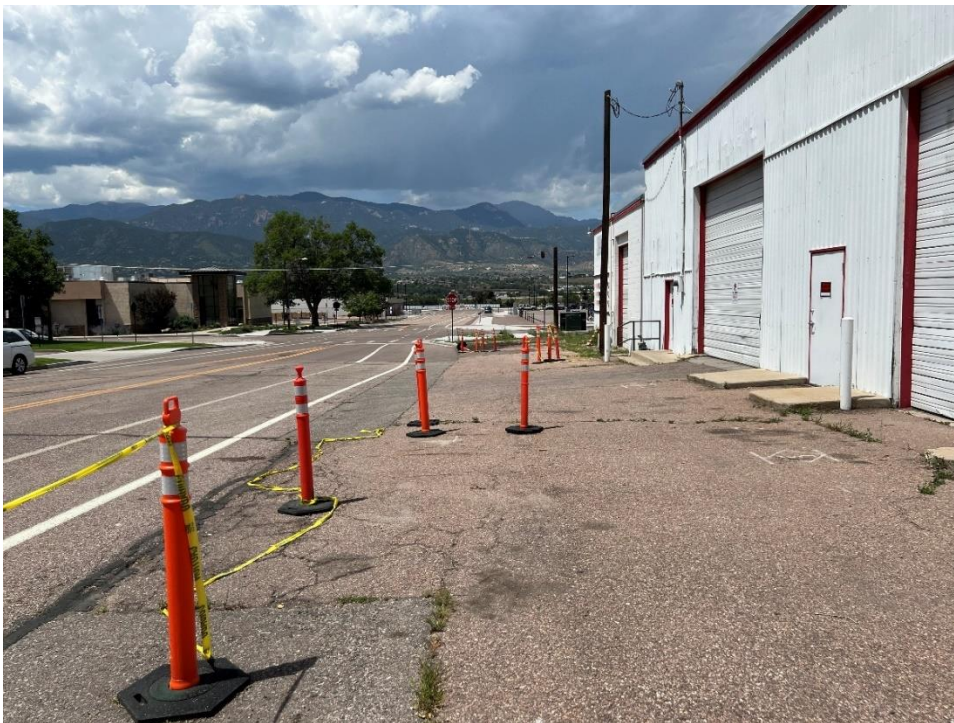
Figure 5. Excessive Curb Cuts Along Commercial Blocks

There is an excessive driveway along Costilla Street for the existing warehouse/storage facilities on parcels 1 and 2, shown in **Figure 5**. The drive covers approximately a third of the block and does not include curb cuts or a sidewalk.

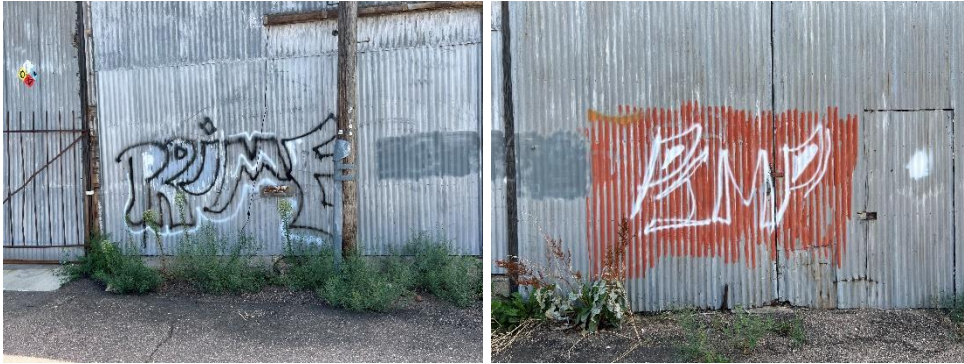
Figure 6. Vandalism/Graffiti

Throughout the Study Area unsafe and unsanitary conditions were documented, including vandalism/graffiti, excessive litter, and evidence of vagrants. Vandalism/graffiti was observed in alley on the backside of the building on parcel 2, shown in **Figure 6**.

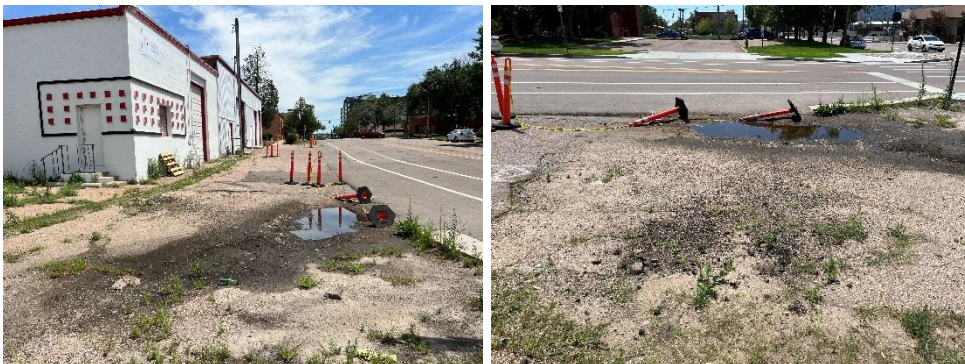
Figure 9. Evidence of Standing Water

Additionally, standing water was observed on parcel 1 along Costilla Street, shown below in **Figure 9**, which may indicate inadequate stormwater drainage.

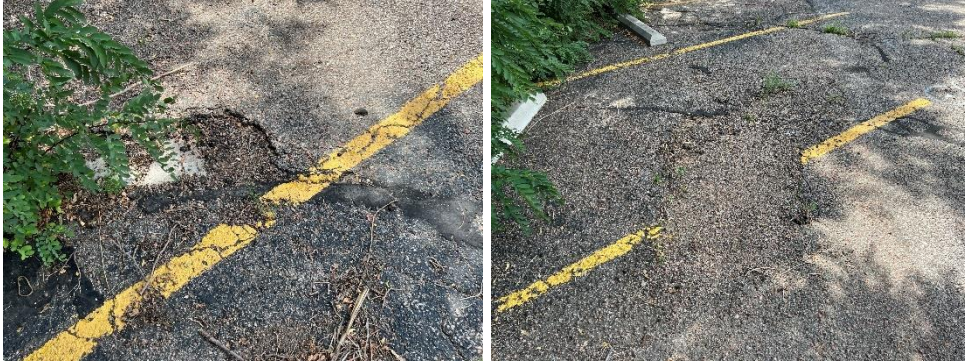
Figure 10. Deteriorated On-Site Parking Surfaces

Deterioration of site improvements were observed throughout the Study Area and overall the site shows signs of neglect. The small parking lot on parcel 4 showed signs of deterioration with missing sections of pavement and pot holes, shown in **Figure 10**.

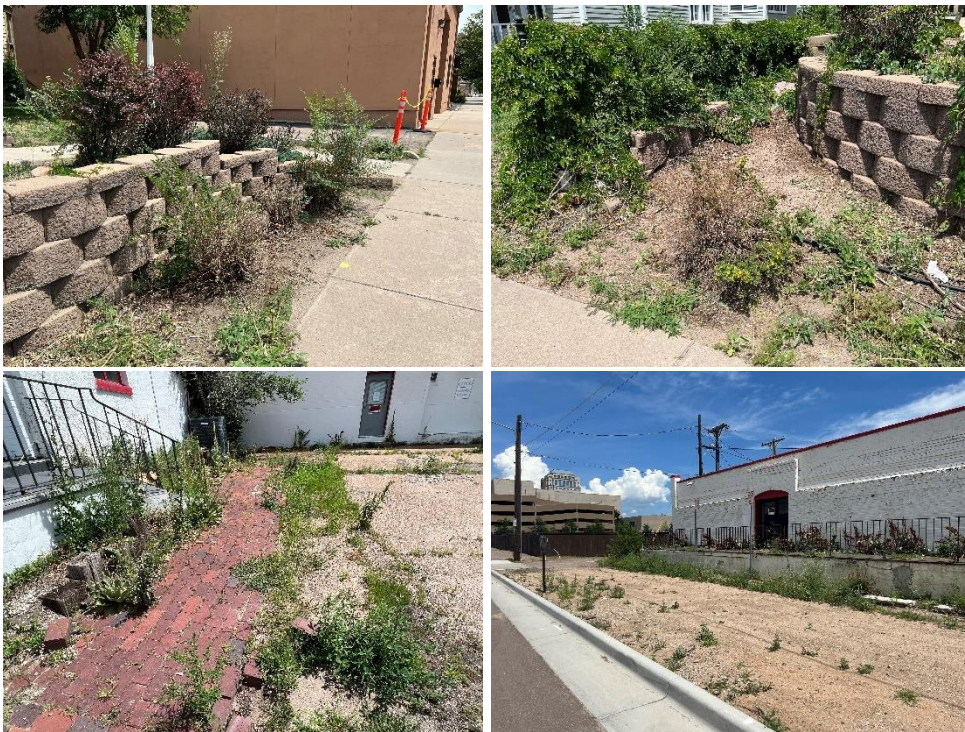
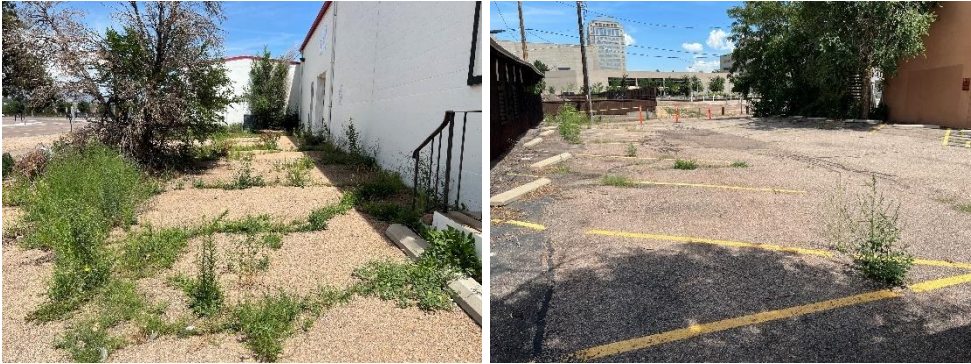
Figure 11. Overgrown Vegetation

Overgrown vegetation and poorly maintained landscaping was observed throughout the Study Area, shown in **Figure 11**.

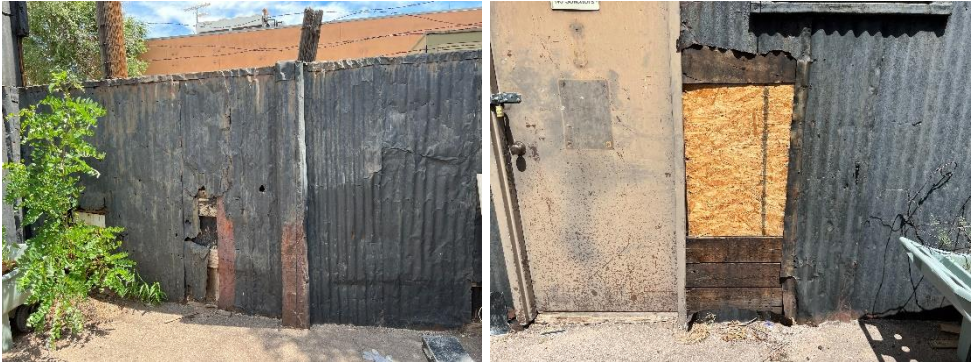
Figure 12. Deteriorated Fences and Walls

On parcel 3 a deteriorated portion of fence and exterior wall of the shed was observed, shown below in **Figure 12**.

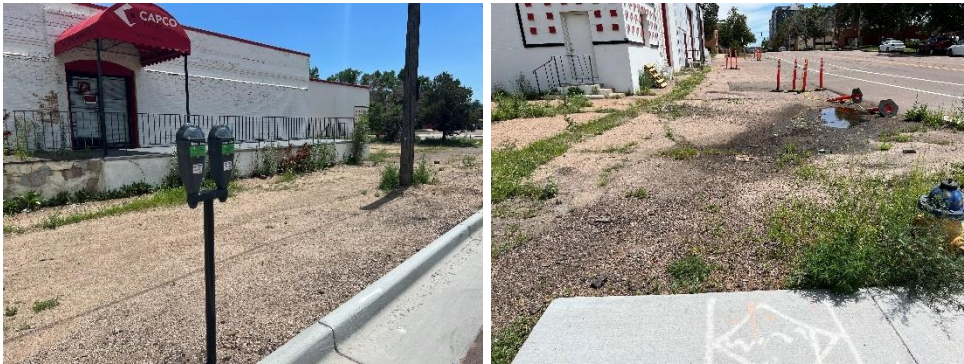
Figure 13. Lack of Sidewalks and Curb

Inadequate infrastructure was observed throughout the Study Area, predominately in the form of deteriorated pavement and lack of curbs and sidewalks. As previously mentioned, there is no sidewalk along Sahwatch Street and Costilla Street on parcels 1 and 2, shown in **Figure 13**.

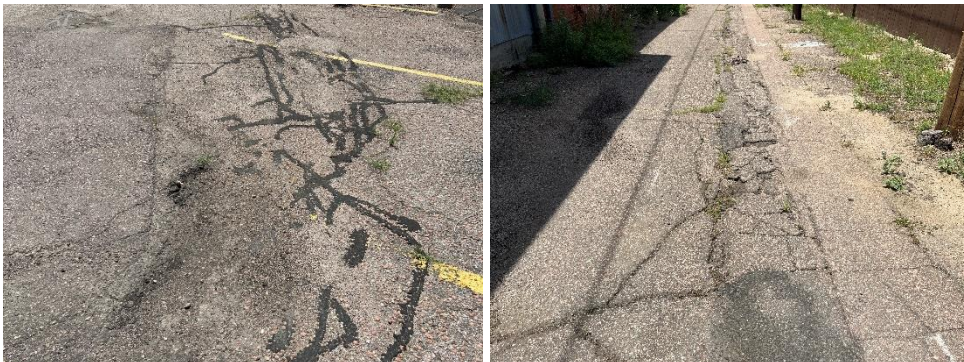
Figure 14. Deteriorated Pavement

In addition, the section along Costilla Street is also missing a curb. Deteriorated pavement was observed on the parking lot on parcel 4 and along the alley behind all the parcels, as shown in **Figure 14**.

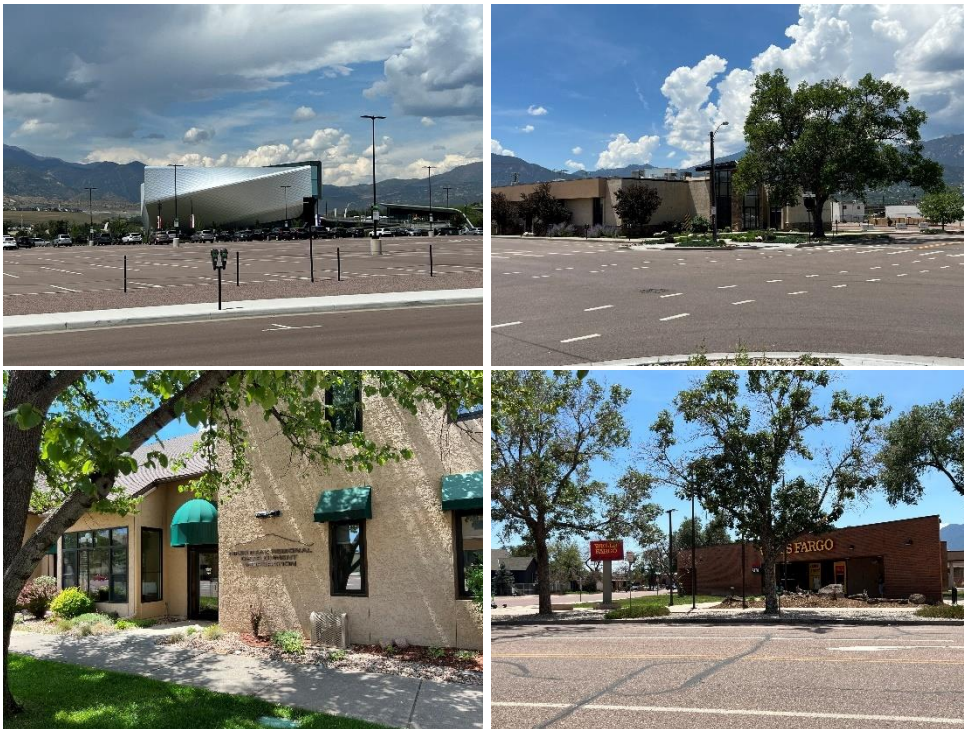
Figure 15. Underdeveloped Parcels in an Urbanized Area

The Study Area is comprised of parcels that are underdeveloped and underutilized in the urban location. The surrounding context of the Study Area is largely developed with commercial uses, shown in **Figure 15**, with the U.S. Olympic and Paralympic Muesum to the west, Colorado Springs Conservatory and Wells Fargo Bank to the south, Pikes Peak Regional Development Corporation to the east, and government buildings on the block to the north. The Study Area is in Downtown Colorado Springs and currently underutilized with older industrial uses and single family residences, all of which are currently vacant.
