Final Report

Zebulon Flats Existing Conditions Survey

City of Colorado Springs Urban Renewal Authority

Economic & Planning Systems, Inc.

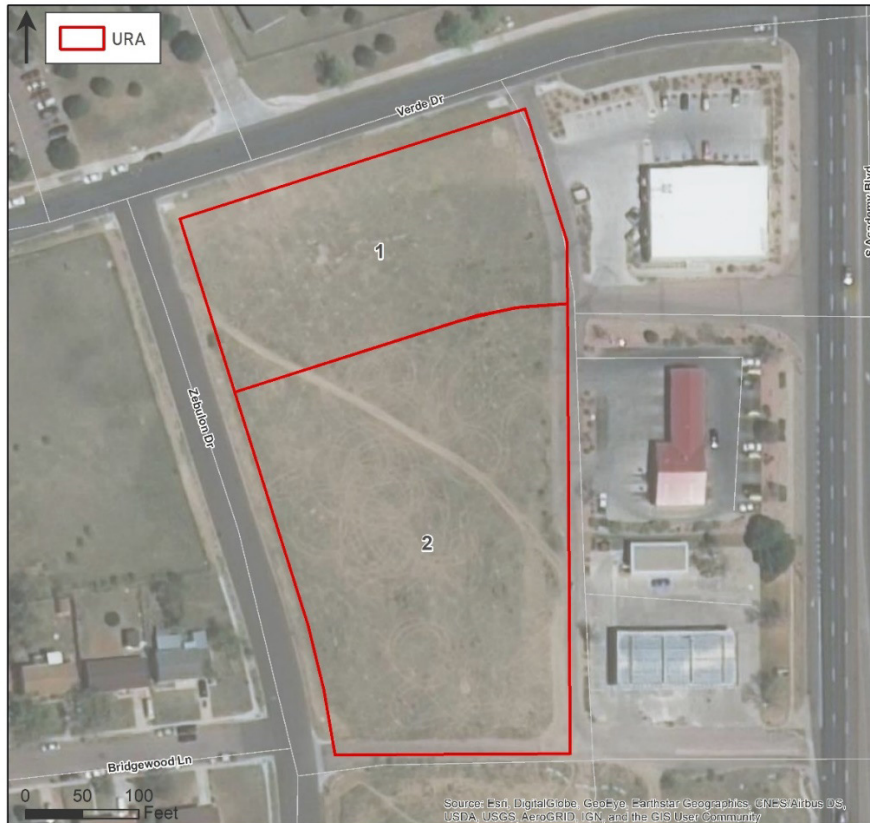
Figure 1. Zebulon Flats Proposed URA Boundary and Parcels

The proposed Zebulon Flats Urban Renewal Plan Area is comprised of two parcels on approximately 3.28 acres of land, as shown in **Table 1** and **Figure 1**. Both parcels are owned by 8844 Neenah LLC. Parcel 1 is the north portion of the property and parcel 2 is the south portion. Both parcels are vacant and have no building improvements.

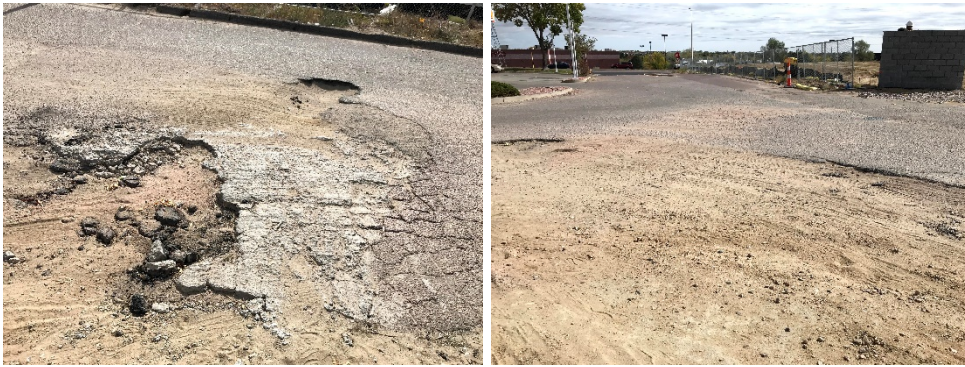
Figure 2. Poor Provision of Street Improvements

In the southeast corner of the Study Area, poor provisions of the streets for vehicular traffic were observed in the form of large potholes and deteriorating pavement, shown in **Figure 2**. Throughout the Study Area, provisions of walkways for pedestrians were observed in the form of lack of sidewalks. In particular in the northeast corner and northwest corner there are curb cuts and the beginning of a sidewalk that abruptly ends, shown in **Figure 3**. Additionally, there were no sidewalk or pedestrian improvements along any of the other perimeters of the property, which is evident in other photos included in this study.

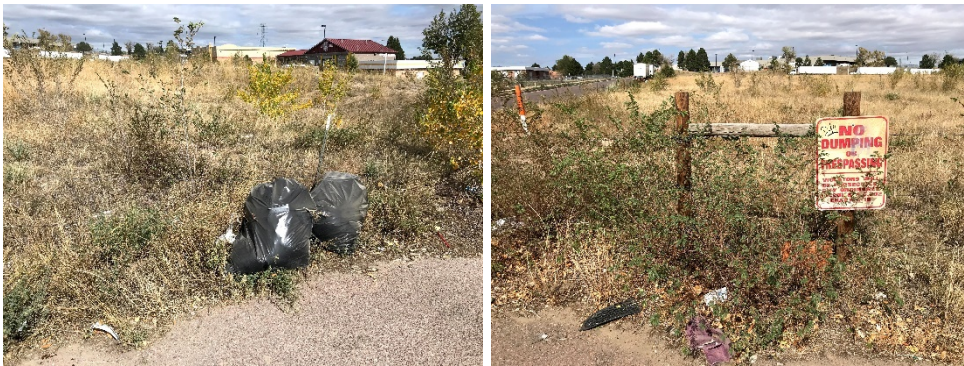
Figure 4. Illegal Dumping

Throughout the Study Area unsafe and unsanitary conditions were documented, including illegal dumping and litter. Illegal dumping was observed at the southern edge of the property, shown in **Figure 4**. Excessive litter was observed and documented throughout the property and along each edge of the property, shown in **Figure 5**. Additionally, there was evidence of crime along Verde Drive adjacent to the property. Broken glass was on the ground, which appears to be from a previous break-in to a parked vehicle, shown in **Figure 6**.

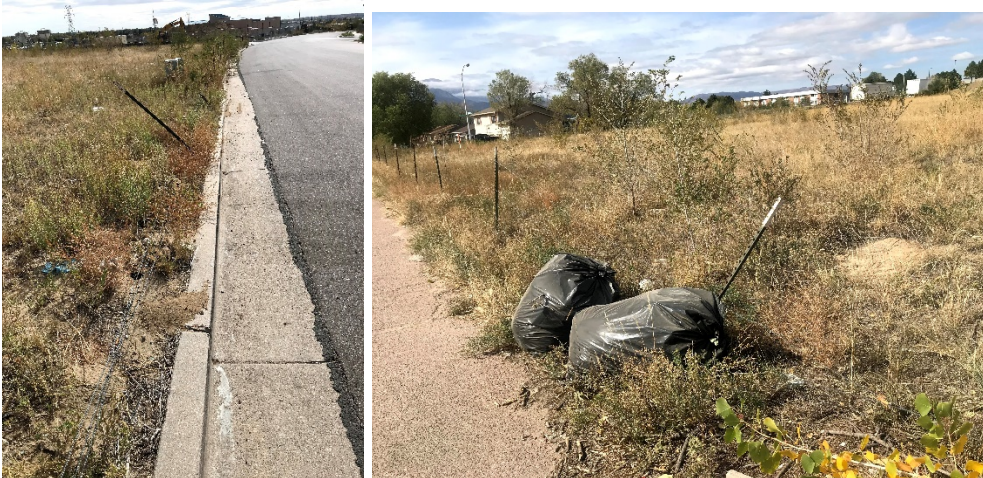
Figure 7. Deteriorated Fences

The deterioration and overall neglect of the property in the Study Area is well documented. The main conditions of site deterioration include the deterioration of fences along the west and south sides of the property (**Figure 7**), deterioration of curbs on the south and east sides of the property (**Figure 8**), and overgrown vegetation on all sides of the property (**Figure 9**). Overall, there was evidence that the property has been neglected with little maintenance.

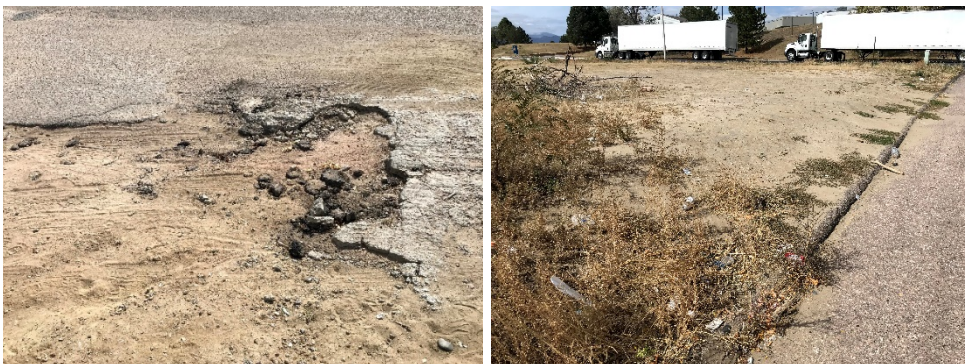
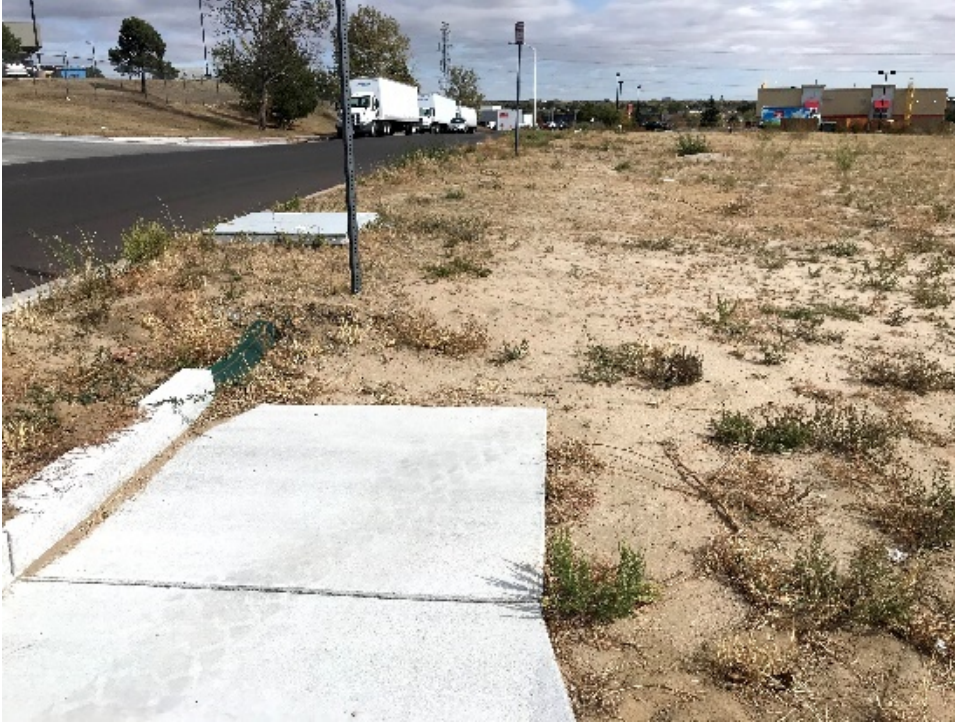
Figure 10. Deteriorated Pavement and Curbs and Missing Sidewalks

Inadequate infrastructure was observed throughout the Study Area, predominately in the form of deteriorated pavement, deteriorated or missing curbs, and missing sidewalks, shown in **Figure 10**. Additionally, unusual topography was observed on the southeast side of the property in the form of steep slopes, shown in **Figure 11**.

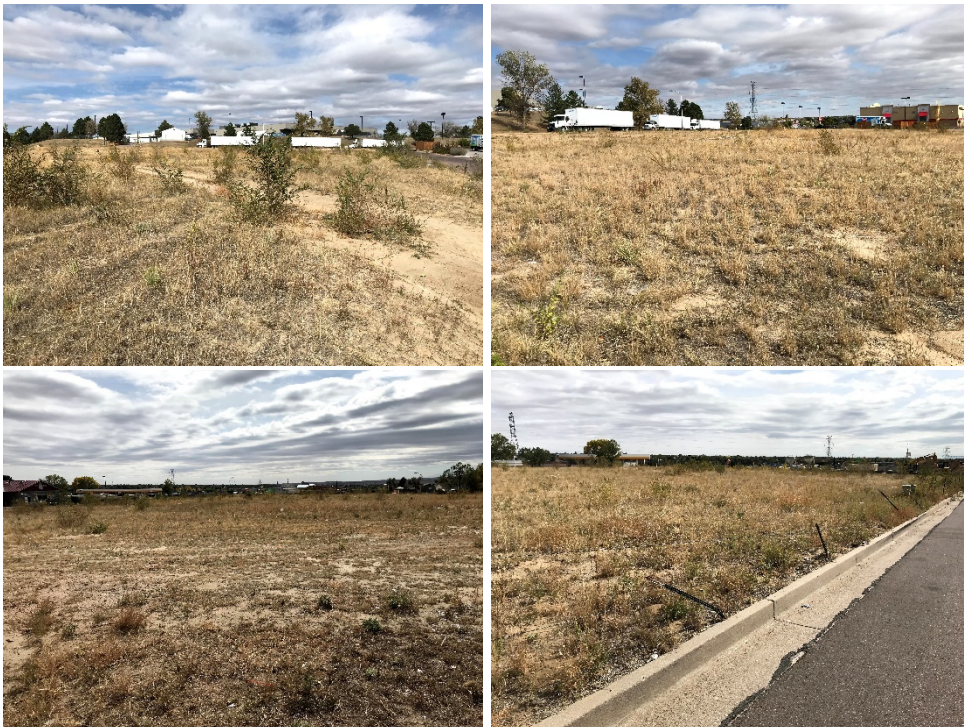
Figure 12. Vacant Property

The entire 3.28 acre property is vacant with no building improvements. The property is surrounded by development with three commercial properties to the east, development to the north, a project under construction to the south, plans for a church to the west, and a housing development to the southwest, shown in **Figure 12**.
