**Conditions Study for
Southwest Downtown Study Area
Colorado Springs, Colorado**

FINAL

June 2018

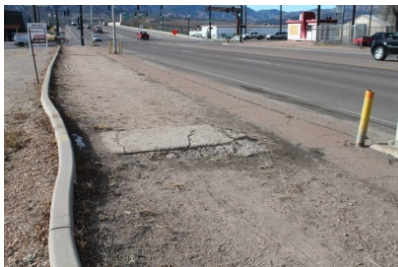
A3

Figure 2-1 Crime Incidents.....	18
Figure 2-2 Substandard driveway/curb cuts, cracked or uneven pedestrian surfaces, unsafe level changes, deteriorated curb and gutter, inadequate and deteriorated sidewalk, non-conformance to development regulations (Photo A-3)	29
Figure 2-3 Substandard driveway/curb cuts, cracked or uneven pedestrian surfaces, unsafe level changes, deteriorated curb and gutter, inadequate and deteriorated sidewalk, non-conformance to development regulations (Photo A-9)	29
Figure 2-4 Multiple examples of deteriorated building exterior and structure, potentially hazardous conditions, unsafe level changes, building code violations, dilapidated building interior, unprotected electrical systems, inadequate fire suppression systems (Photo A-17)	30
Figure 2-5 Presence of trash and debris, substandard driveway/curb cuts, cracked and uneven surfaces, unsafe level changes, deteriorated curb and gutter, inadequate and deteriorated sidewalk, inadequate site maintenance, non-conformance to development regulations (Photo B-11).....	30

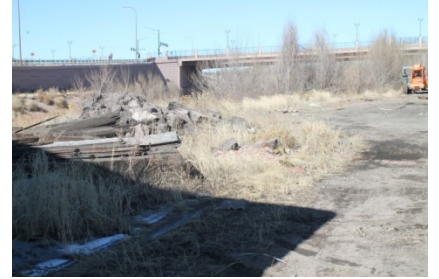
C2

Figure 2-8 Deteriorated visible foundation, deteriorated gutter/downspouts, potentially hazardous conditions, unsafe level changes (Photo C-2)..... 32
